DRAFT Environmental Close-Out Inspection Report

Pine Grove Readiness Center
143 South Tulpehocken Street
Pine Grove, Pennsylvania 17963-1028

May 12, 2014

**Pine Grove Readiness Center –
ISNO: 42D95**

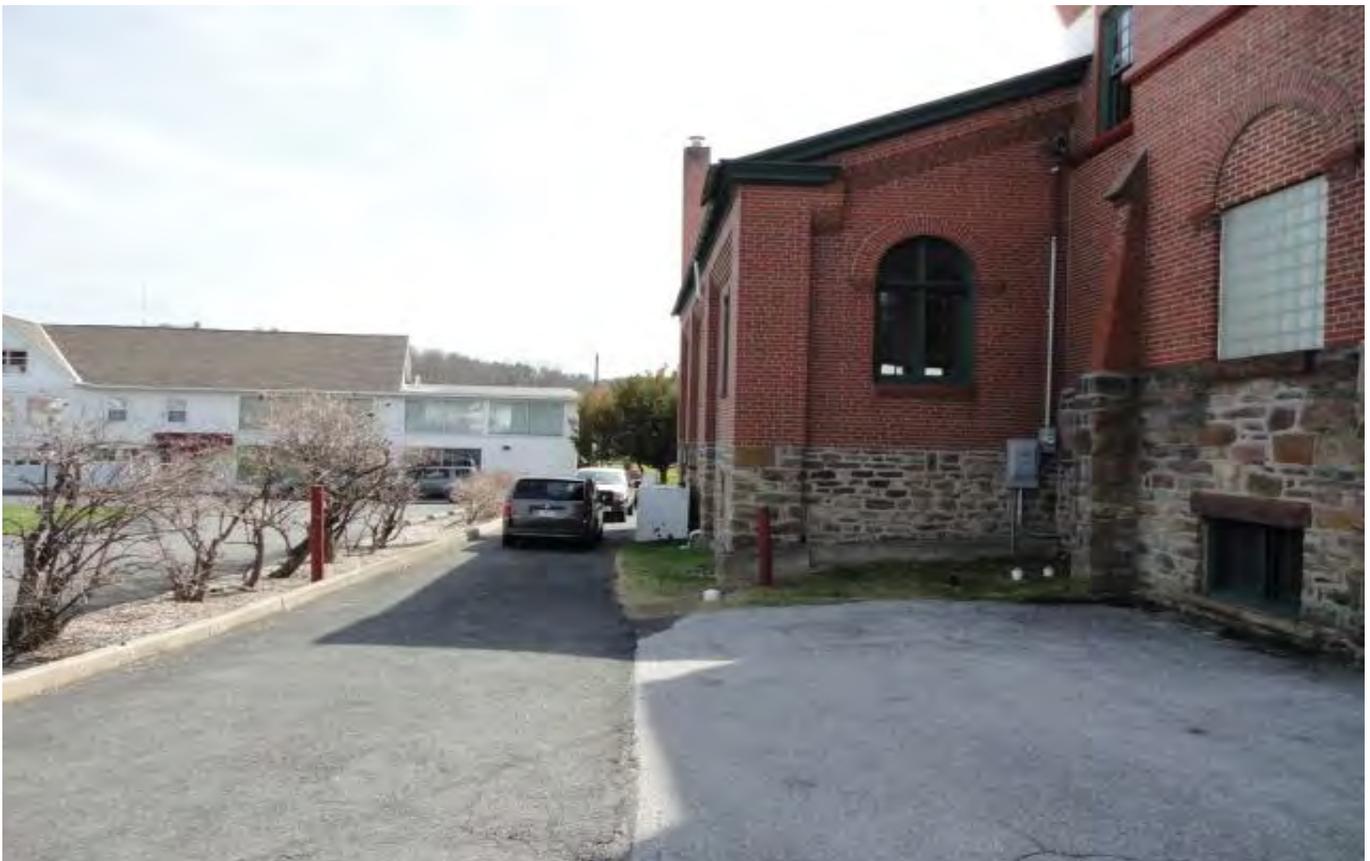
Photograph 2: View of the driveway on the north side of the property. The temporary aboveground storage tank formerly connected to the armory building's boiler system can be seen in the center of the photo, between the building and the gray van.

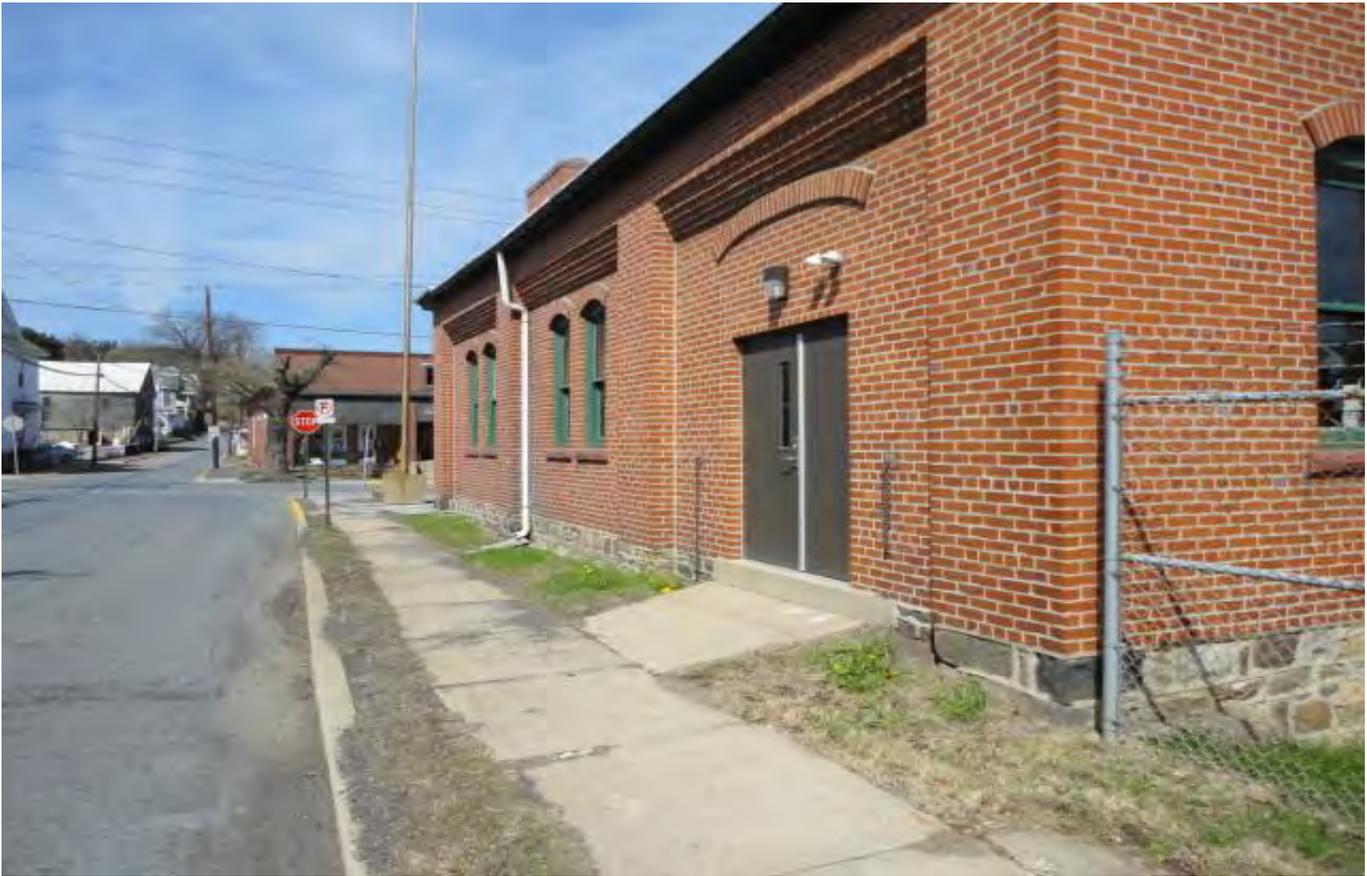
On 4 November 1998, a 95-gallon underground storage tank (UST) containing gasoline was removed from the subsurface at the Pine Grove Readiness Center and taken offsite for proper disposal. This UST was formerly located adjacent to the southeast corner of the armory building, between its exterior wall and the adjacent sidewalk along Mill Street. No obvious impact to onsite soil and groundwater was noted within the tank excavation, and in accordance with the Pennsylvania Department of Environmental Protection's (PADEP's) protocols, a total of three post-excavation soil samples were collected from the soils below the UST and the fuel dispenser for laboratory analysis. The collected soil samples were analyzed for PADEP's shortlist of unleaded and leaded gasoline constituents. The laboratory analytical reports for the collected soil samples indicated that all of the tested parameters were not detected above their respective laboratory detection limits or were detected at concentrations below their respective PADEP statewide health standards (SHS).

Photograph 3: View of the location of the former 95-gallon UST (south side of the armory building). The UST was located approximately near the southeast corner of the building, adjacent to the sidewalk and concrete ramp.

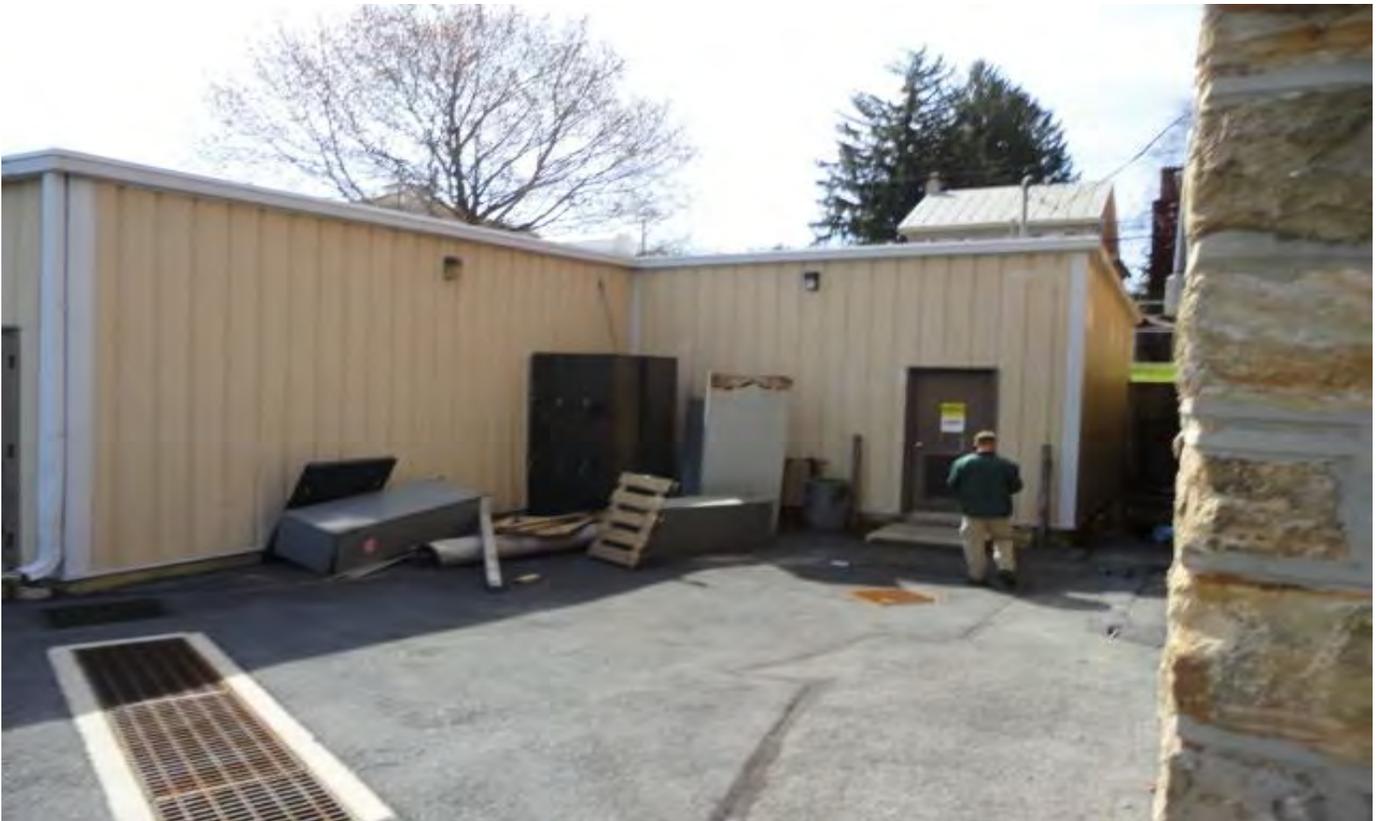
5. Residual soils impacted with No. 2 fuel oil may be present in the former location of a 2,000-gallon underground storage tank onsite. Based on Agency-held documentation, any remaining impacted subsurface soils in this area do not likely pose an immediate threat to human health or the environment.

On 14 November 2011, a 2,000-gallon heating oil UST that held fuel for the armory's boiler was removed from the Site's subsurface and taken offsite for proper disposal. This UST was located near the armory's northeast corner, between the armory building and the adjacent storage building. During tank closure, localized impact from the former UST contents was noted in the adjacent soils and a small amount of water that was perched above the concrete pad on which

the UST was located. Approximately 50-tons of impacted soils (including all other soil removed from the excavation) were excavated, temporarily stockpiled onsite, and later transported offsite for proper disposal. Post-excavation soil samples (total of 13 samples) and groundwater samples (total of two samples) were collected from the excavation, including three soils samples that were collected from below the underlying concrete pad. Laboratory analysis of the collected soil and groundwater samples did not indicate the presence of any heating oil parameters above their respective residential SHS. The excavation was backfilled with new gravel and later paved. According to correspondence received from PADEP, this tank incident site is not currently subject to further remedial action by order of PADEP and has satisfied its remedial requirements to date.

Photograph 4: View to the east of the exterior storage building. The former location of the 2,000-gallon heating oil UST can be seen in the photograph's lower right hand corner.

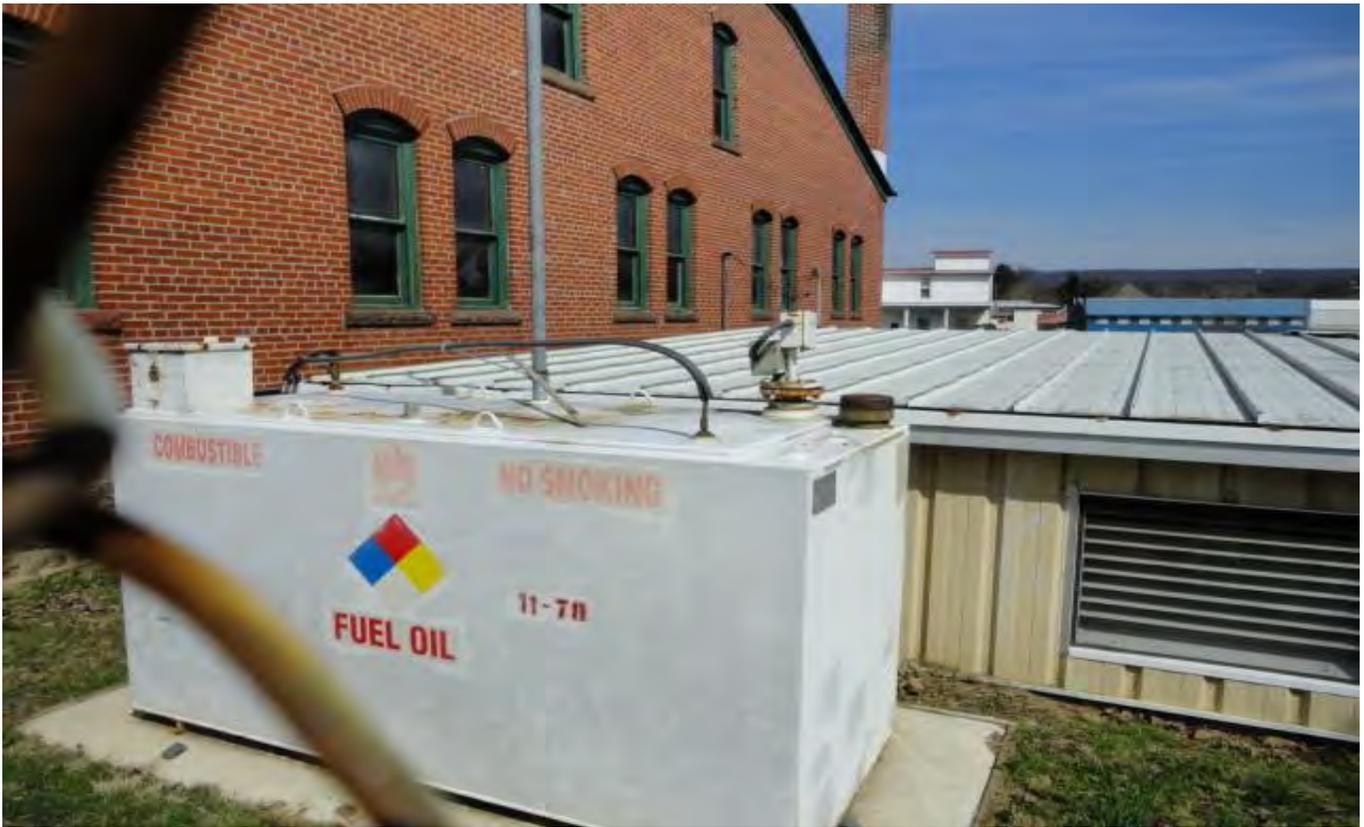
Photograph 5: View of the 1,000-gallon AST on the Site's south side.

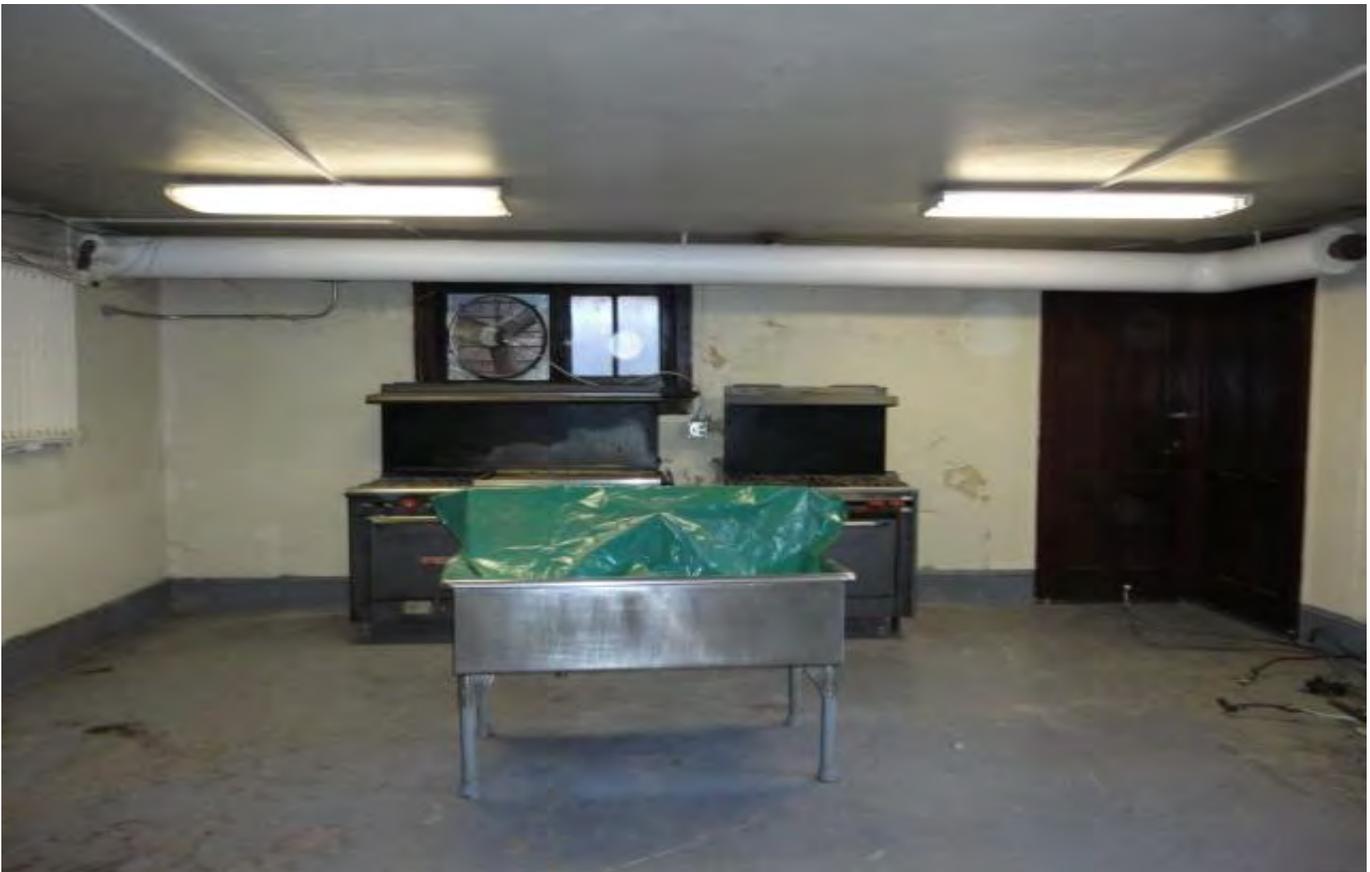
2. A formal asbestos survey was completed for this facility in January 1997. Suspected asbestos containing materials (ACMs) were observed during the closeout inspection, mostly in the form of pipe insulation and associated fittings in the basement kitchen, latrine, and boiler room. A small area of floor leveler located in the first floor hallway also tested positive for asbestos. During the closeout inspection, the previously identified ACMs in the noted basement areas appeared to have been previously removed and replaced with modern fiberglass insulation materials, as shown on the applicable photographs in the attached Appendix B. Any remaining materials should be managed in accordance with best management practices for ACMs, including repair, removal/abatement, or encapsulation, as applicable.

Photograph 8: View of the basement kitchen and remaining items, including newer fiberglass insulation on the overhead pipes.

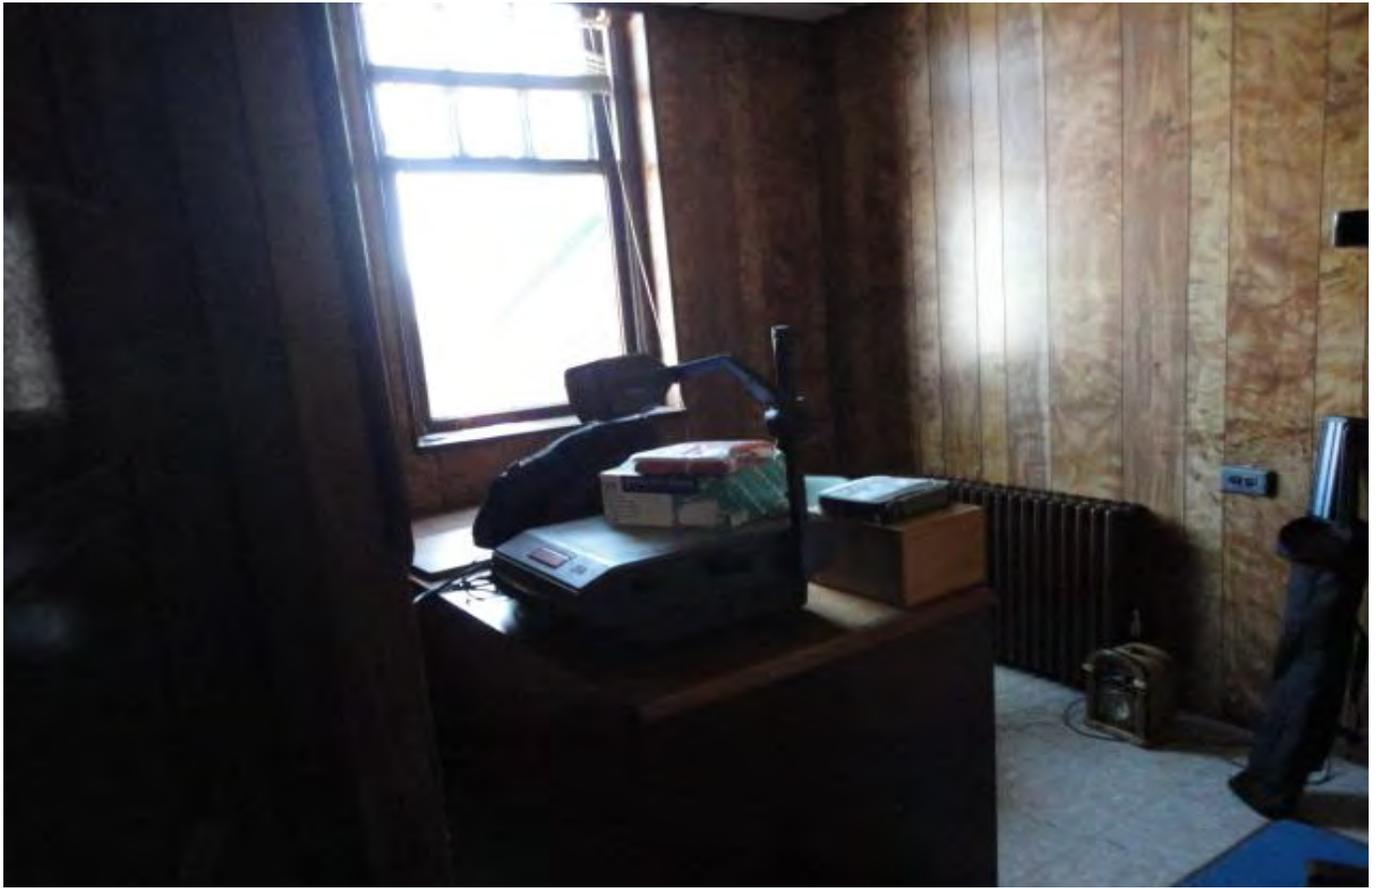
Most of the furniture, appliances and other miscellaneous state-owned and other property were removed from the Armory building prior to this closeout inspection; but some miscellaneous items (e.g., shelving, desks, and chairs) are still present, particularly in the second floor recruiter's office and the basement storage rooms. These items are reportedly going to be removed for use at other PAARNG facilities or otherwise left in the building. Two stoves in the kitchen are likely to remain in the building (unless USPFO wishes to remove them or another facility has a need for these items), while the remaining stainless steel sink is reportedly slated for use at another PAARNG facility.

Photograph 11: View of remaining items in the second floor recruiter's office.

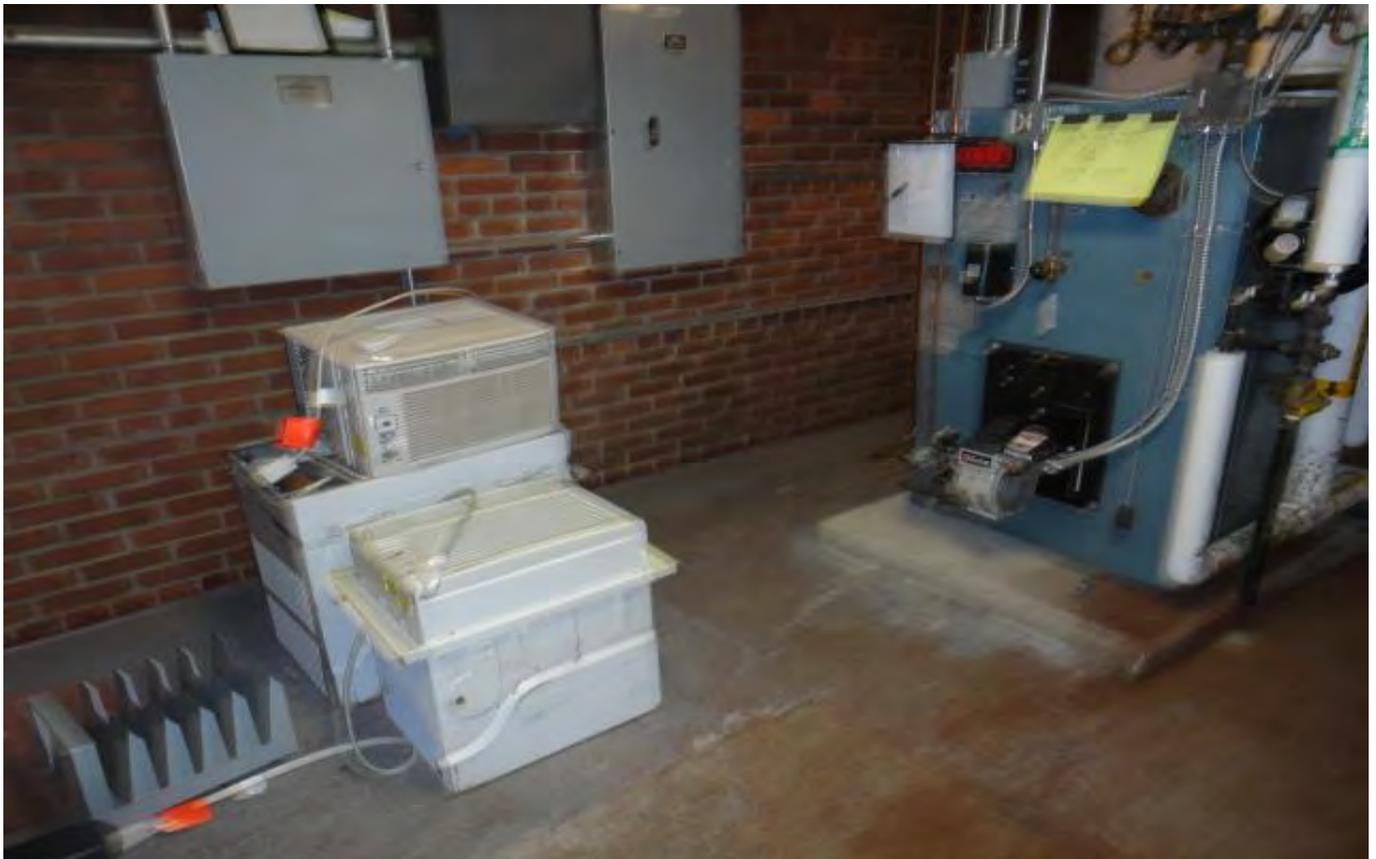
Photograph 12: View of remaining window air conditioning units and the boiler system in the armory's basement.

4. Electronic or appliance-type items, such as three air conditioning units noted in the basement boiler room should be reused, or otherwise determined to be wastes and disposed of properly, in accordance with the applicable federal, state, and local laws.

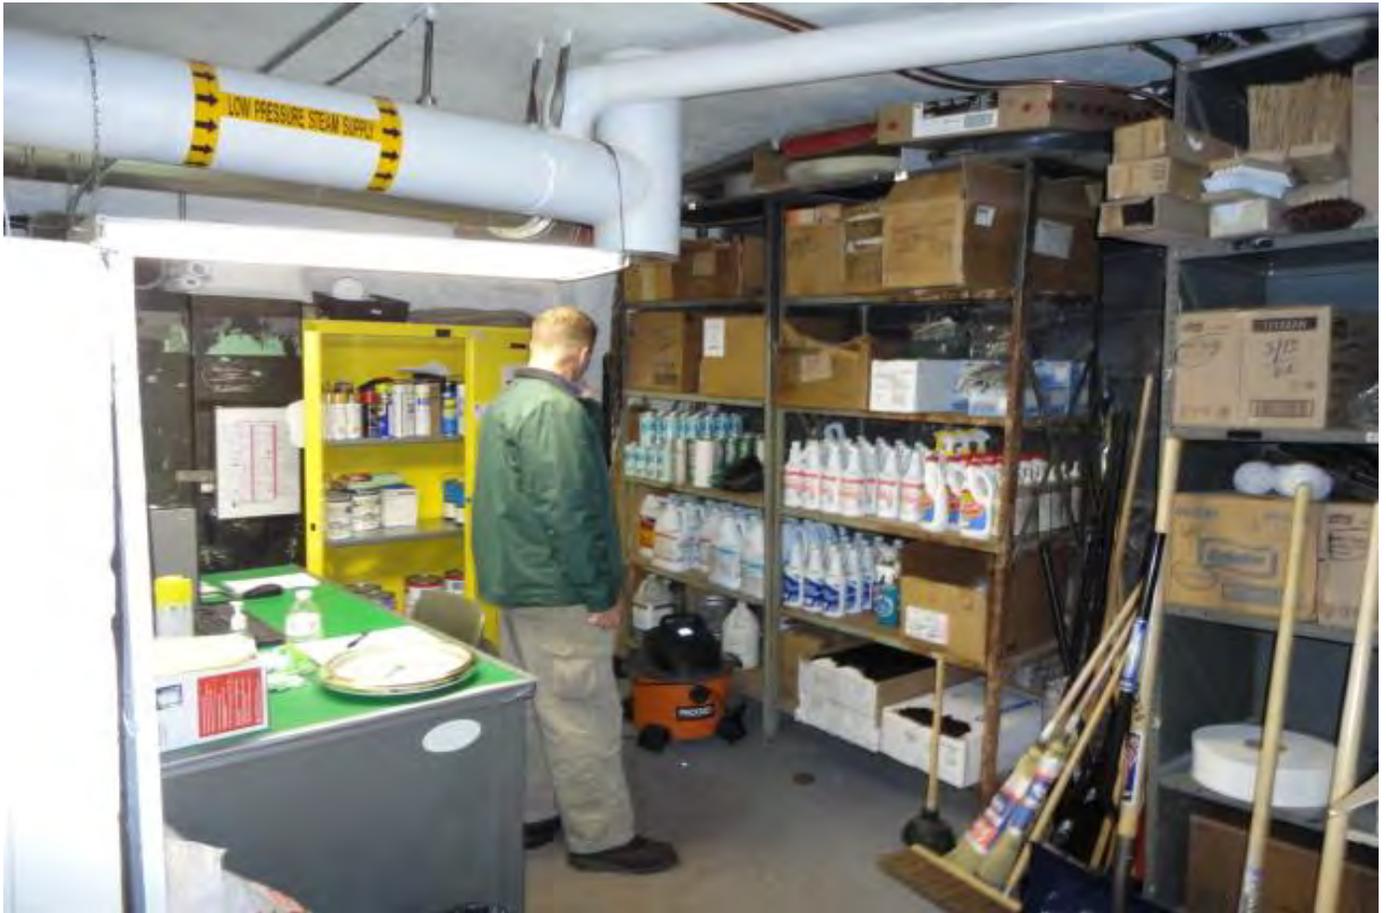
The property has been mostly cleared of chemicals or other hazardous substances, with the exception of common cleaning chemicals (glass cleaner, all-purpose surface cleaners, etc.), enamel and latex paints, spray insecticides, floor stripper, and spray lubricants noted in the chemical storage cabinets and shelving in the armory's basement maintenance office. A 5-gallon container labeled as "Cavicide" (a typically medical-grade surface cleaner/surfactant and disinfectant) was observed near the basement's rear entry door. The first floor maintenance closet also contained a small amount of household cleaning chemicals, including glass cleaner and an all-purpose surface cleaner. All chemicals remaining onsite appeared to be stored properly and storage areas did not appear to be impacted by spills or container leaks.

Photograph 13: View of remaining chemical storage in the basement maintenance office. Note the newer fiberglass insulation around the overhead boiler piping.

The items described in Sections 8.1 and 8.2 of this report should be reused where possible, or otherwise determined to be wastes and disposed of properly.

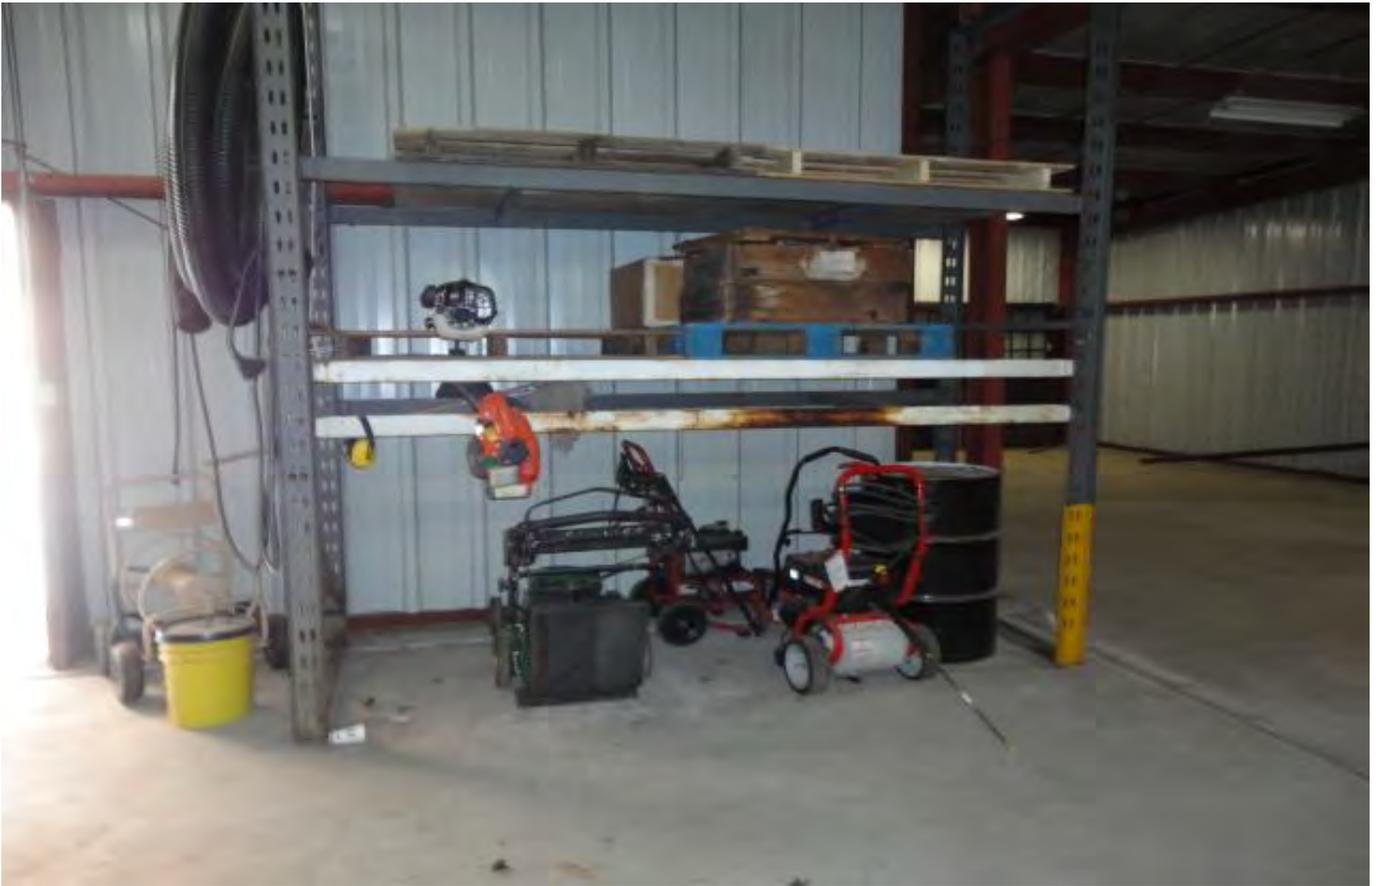
During the Site reconnaissance, small gasoline cans and gas/oil mix containers were stored within a flammable materials cabinet in the exterior storage building. A mostly empty to empty 55-gallon drum, labeled "waste oil" was also noted in this building. Observation of the storage building and surrounding area did not suggest the presence of a release of petroleum, oils, and lubricants (POLs) to the environment. Additional POLs, chemicals, etc. remaining on the property are described in Section 8.2 of this report.

Photograph 15: View of remaining items in the western portion of the storage building, including maintenance equipment and an empty waste oil drum.

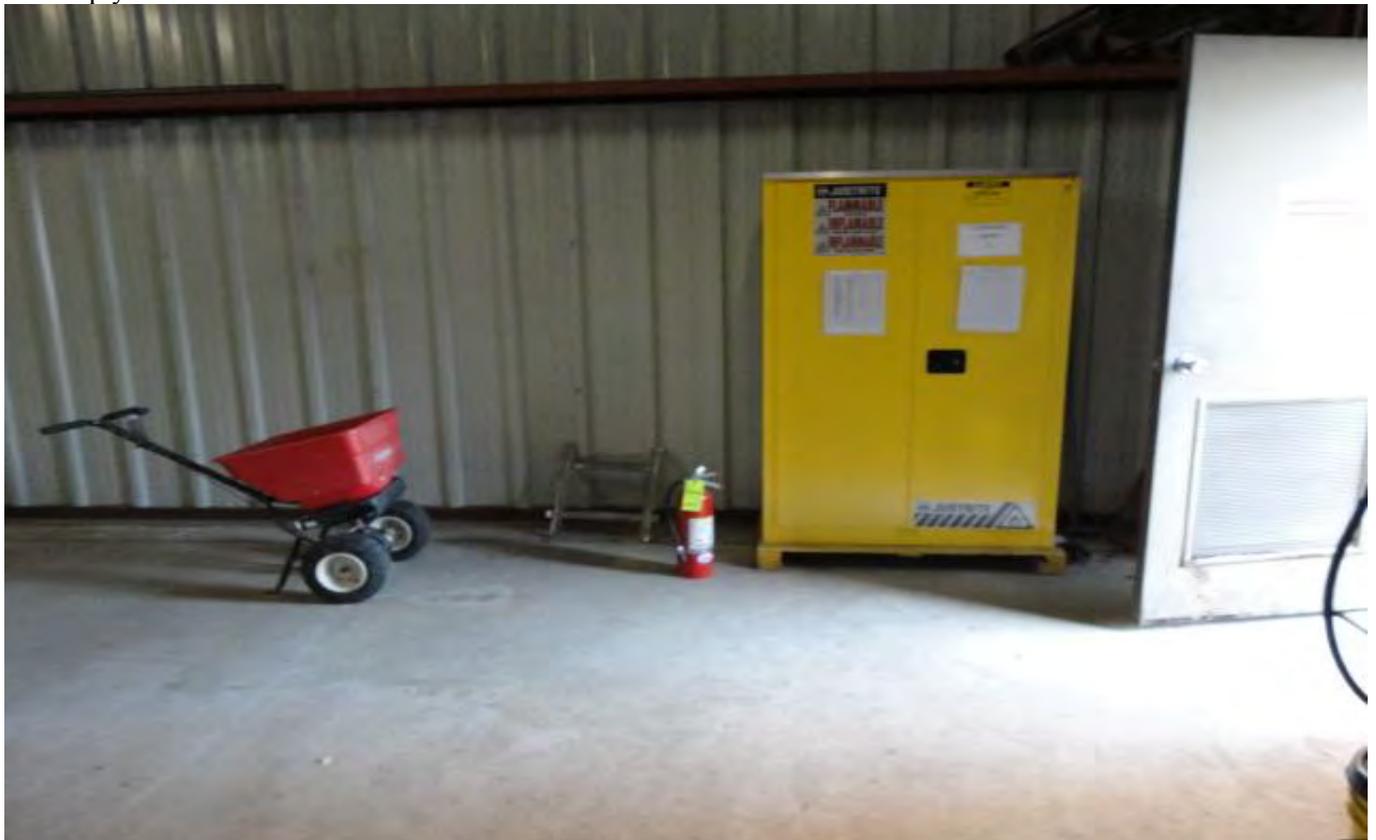
Photograph 16: View of flammable storage cabinet in the exterior storage building containing gasoline and other petroleum products for use in maintenance equipment.

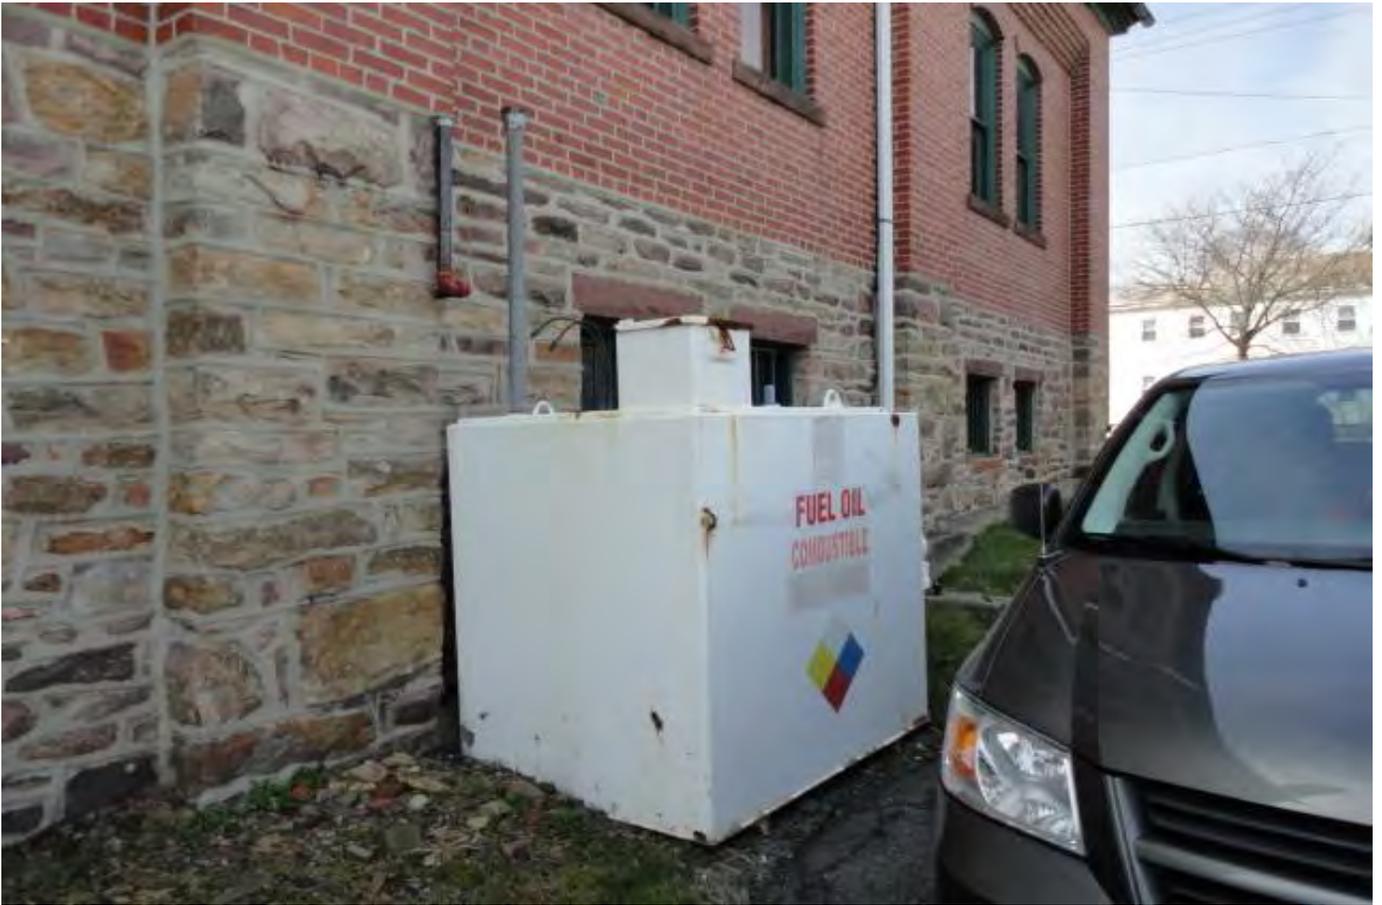
Currently, there are no underground storage tanks (USTs) located on the Site. Two aboveground storage tanks (ASTs) are present on the property. An approximately 500-gallon AST was temporarily utilized to fuel the armory's boiler system after the former 2,000-gallon UST was closed by removal. This AST was disconnected from the boiler system sometime in 2012, when a 1,000-gallon AST was installed to fuel the armory's new boiler heating system. The temporary 500-gallon AST is still present on the property, and is located adjacent to the north side of the armory building (exterior). The 1,000-gallon AST is located on the south side of the property, between the storage building and the adjacent fence. Both storage tanks did not show visual or olfactory obvious signs of leaks, spills, or releases during the Site reconnaissance. According to Mr. Ty Wagner, the 500-gallon AST is slated for removal and transport to Fort Indiantown Gap. Two approximately 100-pound natural gas cylinders remain on the exterior of the armory buildings' south side. These cylinders were previously disconnected from the kitchen facilities and are scheduled to be removed by the owner.

Photograph 17: View of disconnected approximately 500-gallon AST on the north side of the armory building.
