# **FINAL Environmental Close-Out Inspection Report**

Kane Readiness Center – Installation ID: 42C40  
208 Chestnut Street  
Kane, PA 16735-1603

Kane Weekend Training Site – Installation ID: 42C45  
Ash Street  
Kane, PA 16735-1603

February 14, 2017

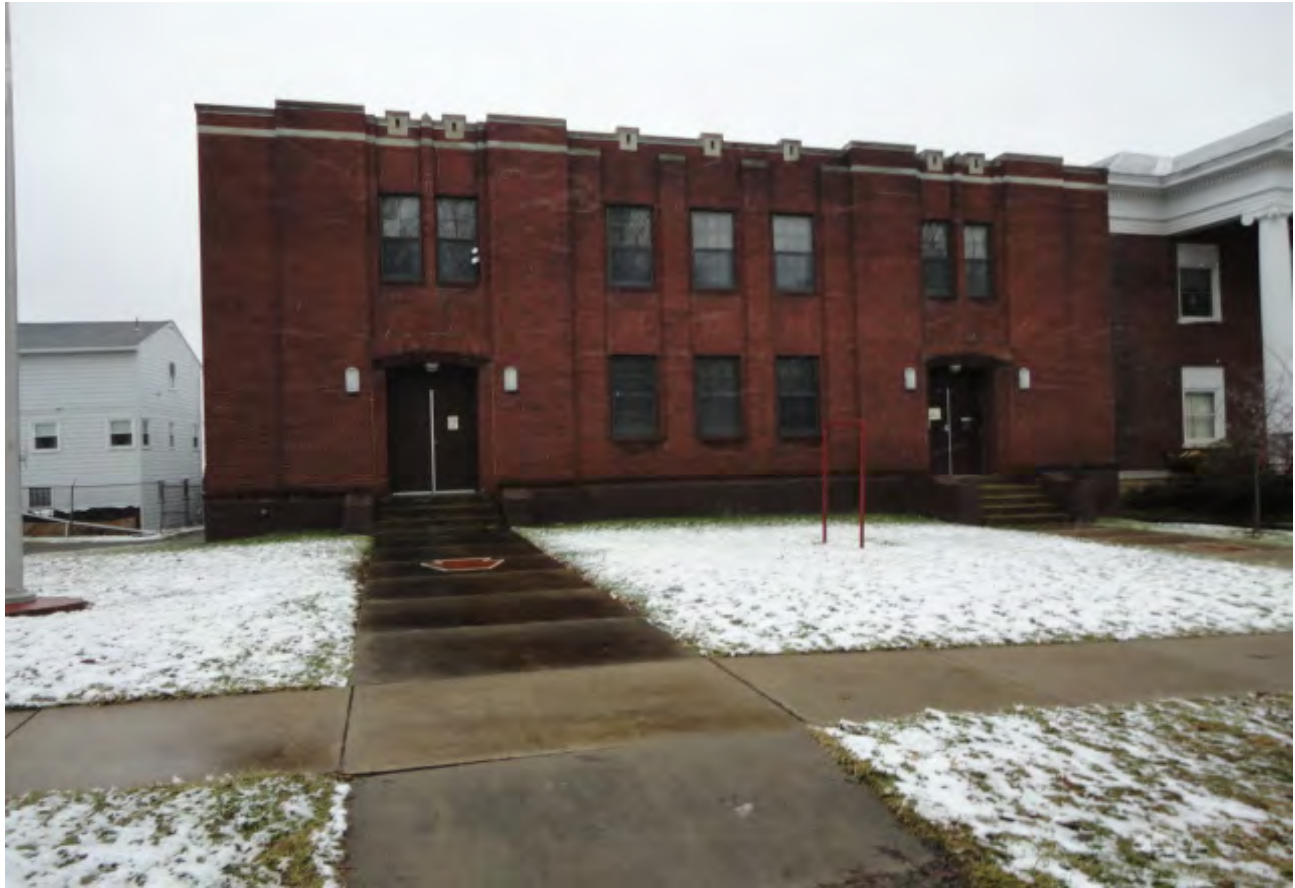
Photograph 1: View to the north of the Kane RC's exterior.

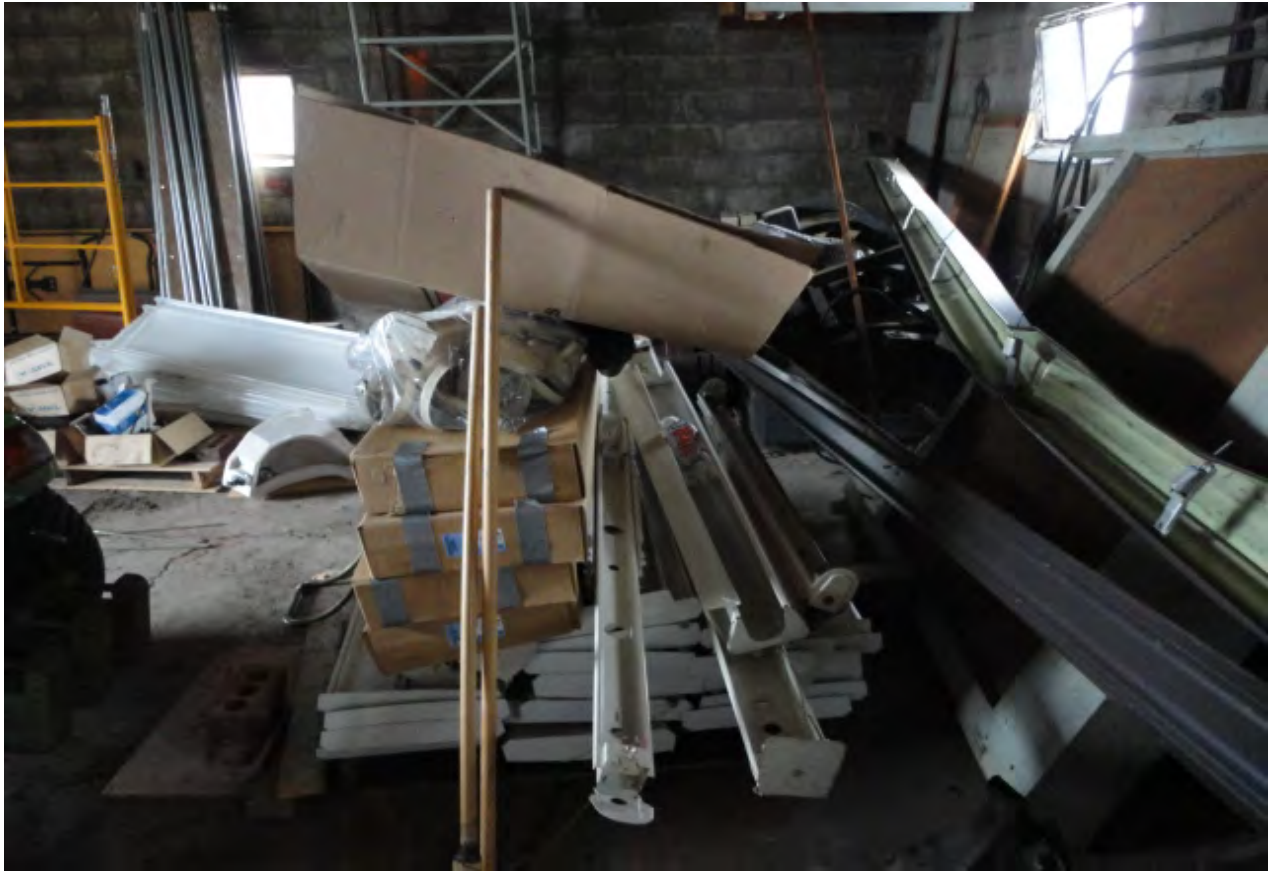
Photograph 5: View of materials (old lighting fixtures and ballasts, waste light bulbs, scrap metal, etc.) in the garage building awaiting transport for recycling, disposal, and/or reuse.

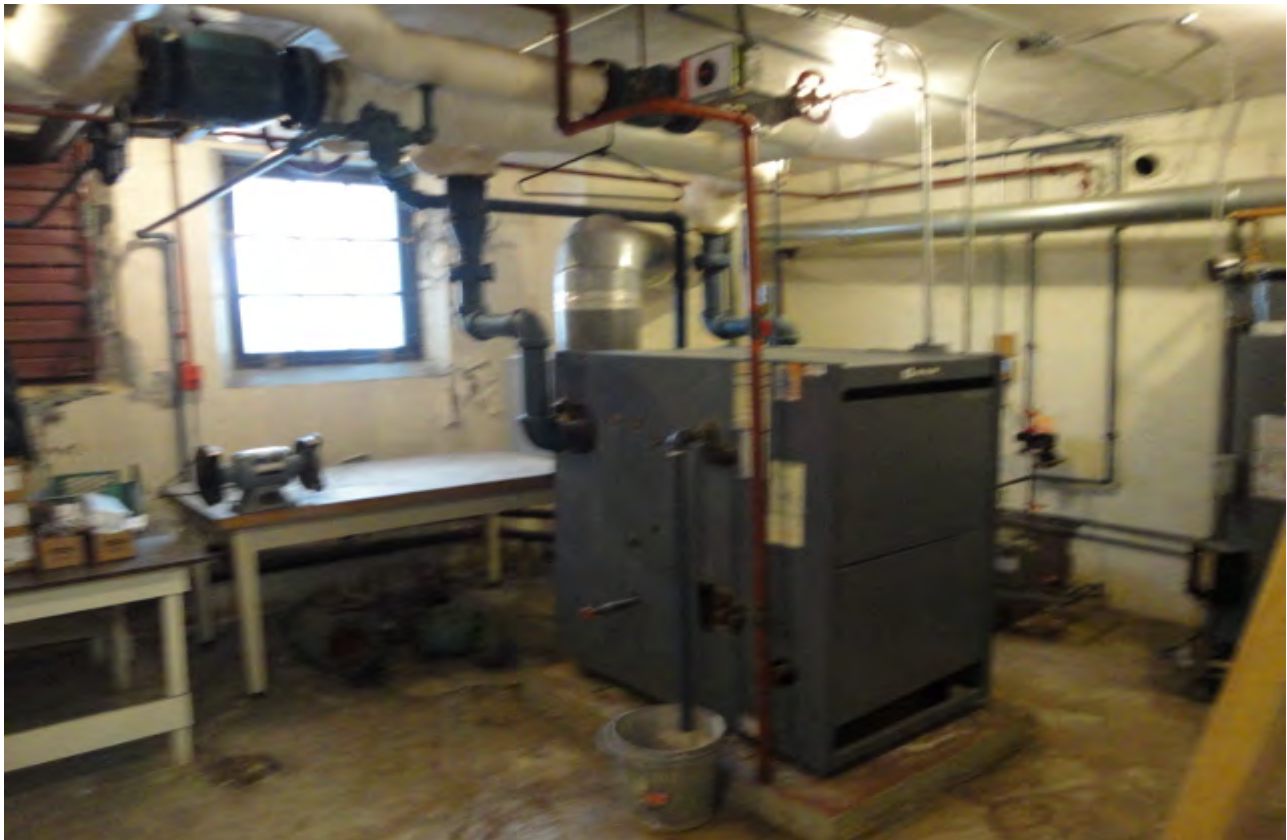
Photograph 6: View of the boiler room in the RC basement.

The facility currently contains a natural gas-fired boiler system for heating. Several window-mounted air conditioners were observed in storage or in use on the first and second floors of the RC building.

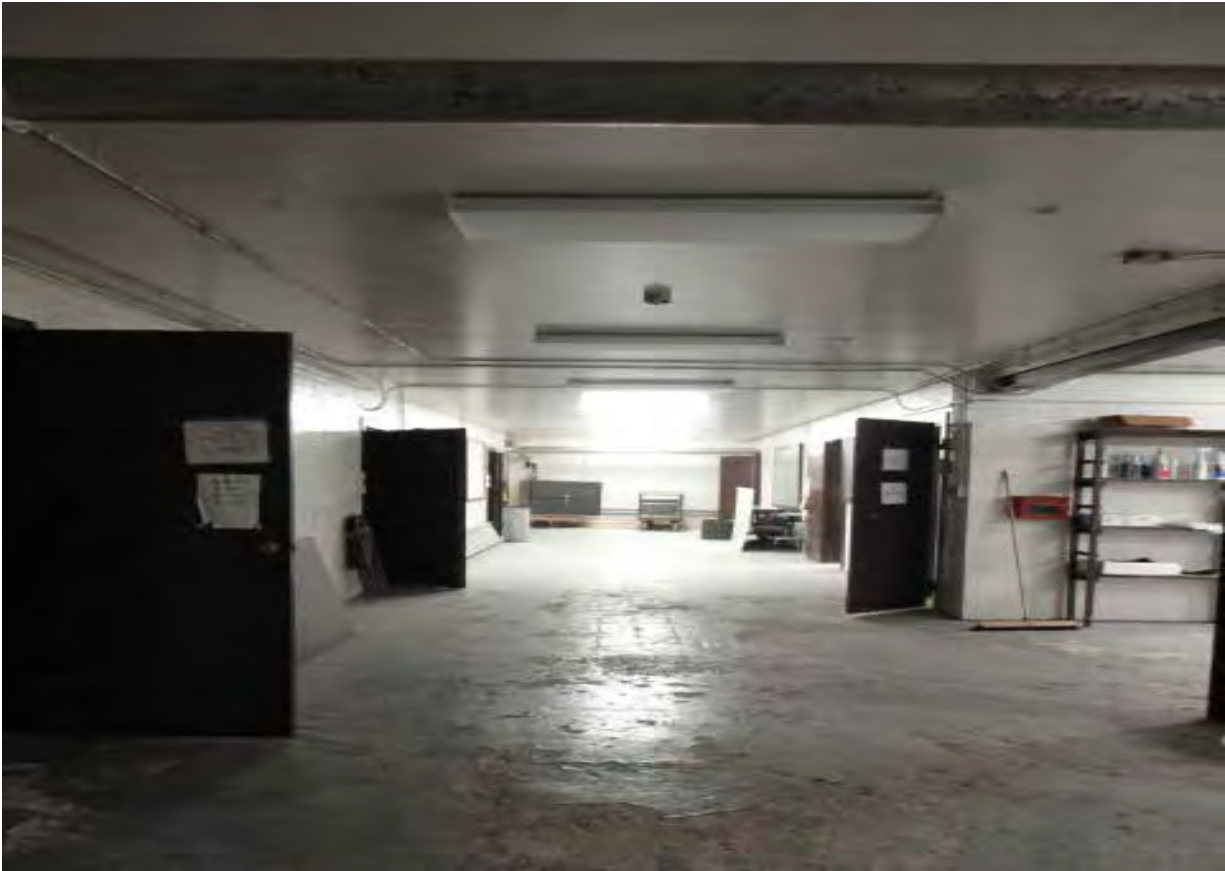
Photograph 7: View to the north of the former IFR in the RC basement.

2. The Kane RC parcel contains a basement space formerly utilized as an indoor firing range (IFR) for small caliber firearms training. This range was previously closed and subject to decontamination activities in February 2003. Based on recent sampling for lead dust in the former IFR area and in other locations throughout the RC building, elevated concentrations of lead dust still remain in some areas of the building.

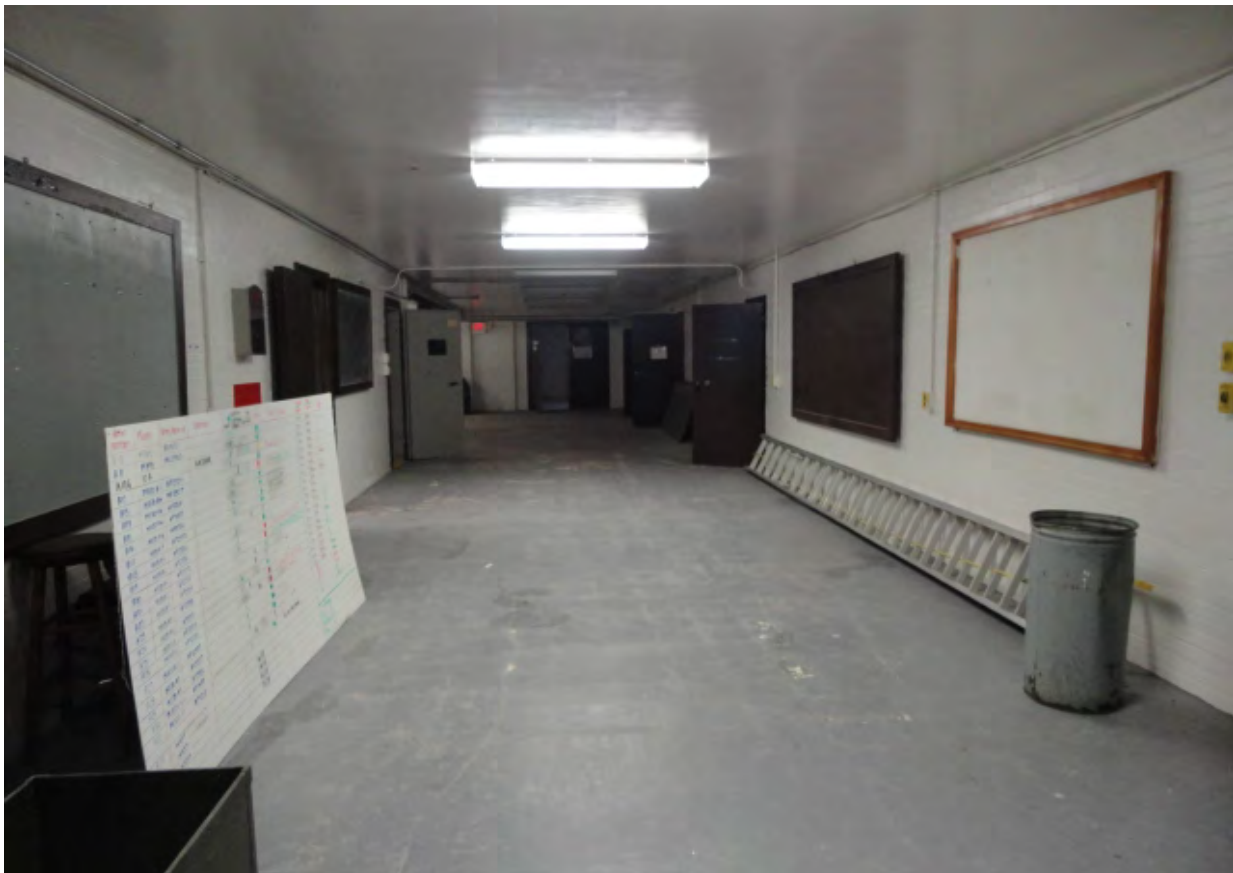
Photograph 8: View to the south of the former IFR space, near the target area.

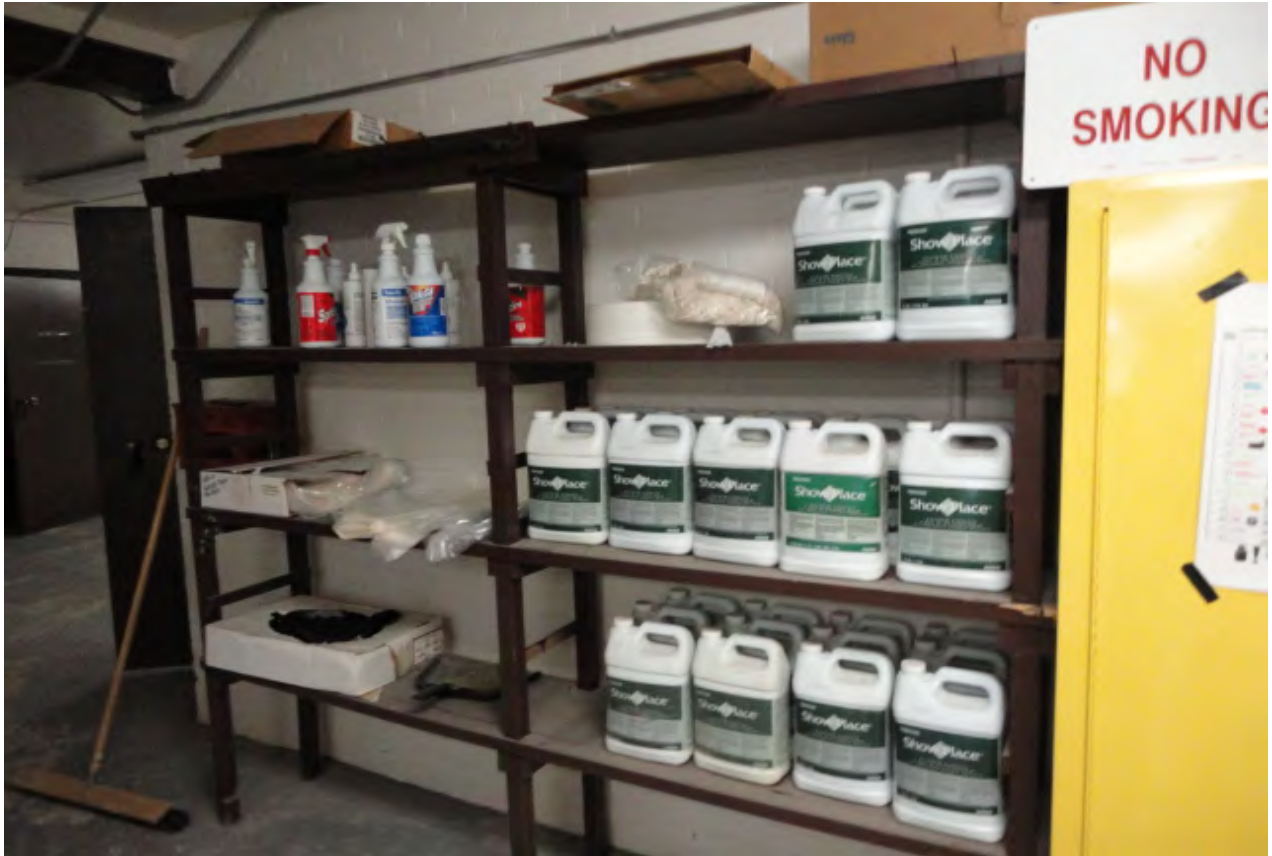
Photograph 9: View to the north of the main area of maintenance chemical storage in the RC basement.

Multiple types of potentially hazardous materials remain onsite, chiefly in the maintenance storage areas of the Kane RC building and associated garage. All materials were stored properly and are slated to be moved to other PAARNG facilities for use, or otherwise turned in for disposal once sale of the Kane RC parcel is final. The Bureau of Environmental Management (Ms. Dreama O’Neal at (717) 861-9601) can assist the former occupying unit and/or maintenance staff in making a waste determination and arrange for disposal of unwanted or unusable hazardous items.

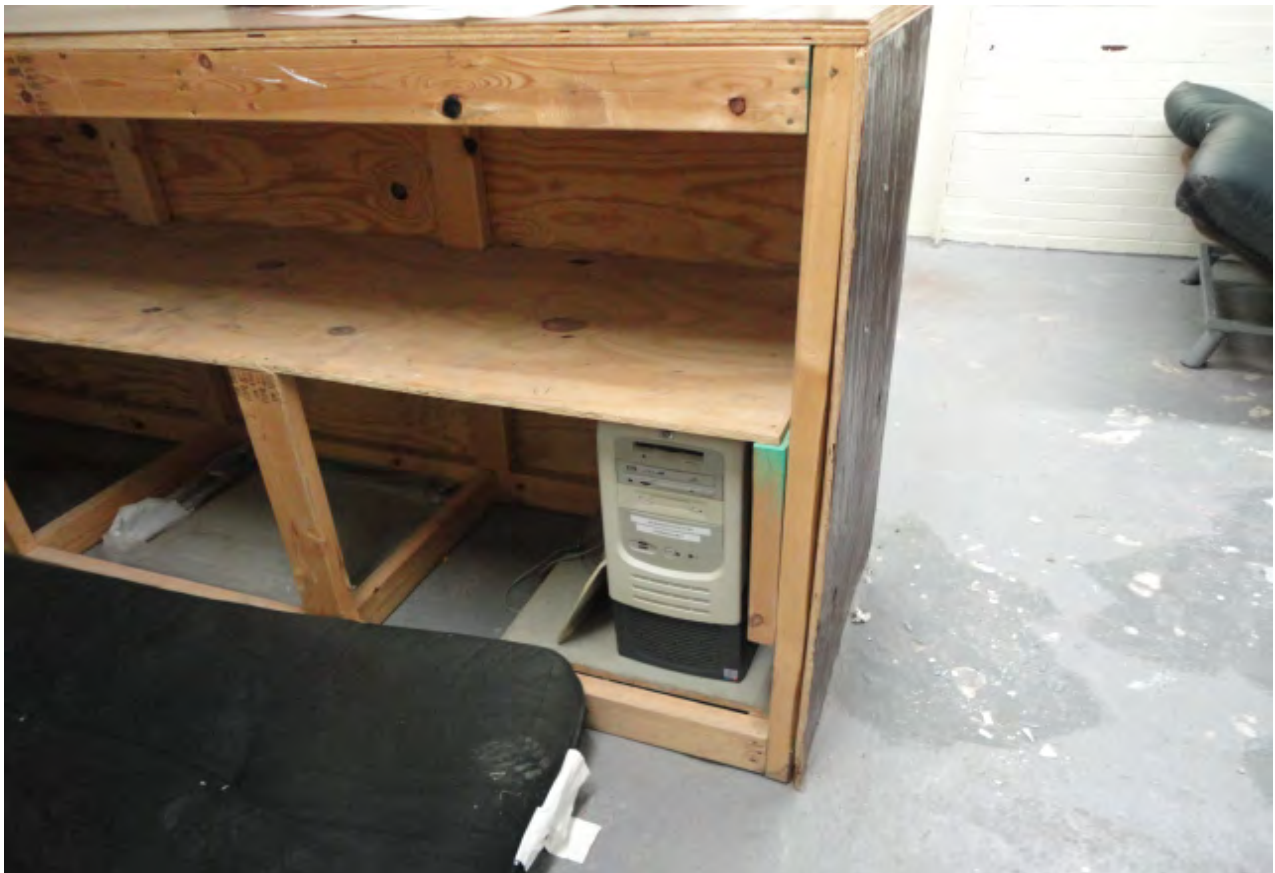
Photograph 10: View of a computer left in the RC basement.

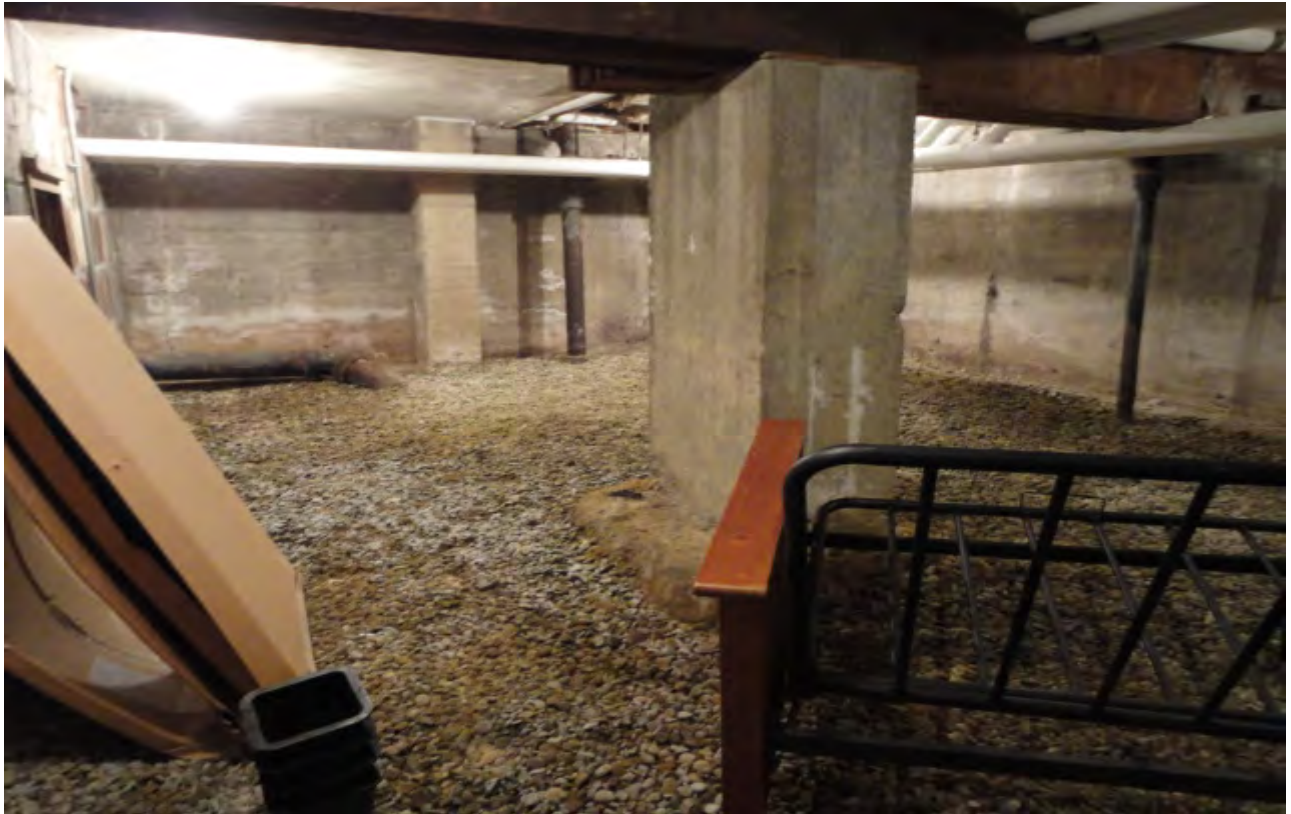
Photograph 11: View of storage crawlspace in the northern side of the basement where ACMs were previously abated.

A formal survey of the Kane RC parcel for asbestos containing materials (ACMs) was completed in March 1997. Several building materials within the RC were identified as containing asbestos, including 9-inch by 9-inch floor tile of various colors, floor tile mastic, various sizes of mud fittings associated with piping insulation, and thermal system insulation (TSI, "pipewrap"). Built-up portions of the RC roof were assumed to contain asbestos and were not sampled at that time. Obvious signs of damaged ACMs were not observed during the Site reconnaissance. An interview with Mr. Kessler and a visual assessment of remaining insulation materials in the basement of the RC indicated that much of the ACMs present at the time of the survey were previously abated during renovation-type work in this part of the RC. The remaining materials identified as ACMs, particularly floor tile, appeared to be in generally good condition where present in the RC building. An abridged summary copy of the ACM survey for the Kane RC is included as Appendix E of this report.

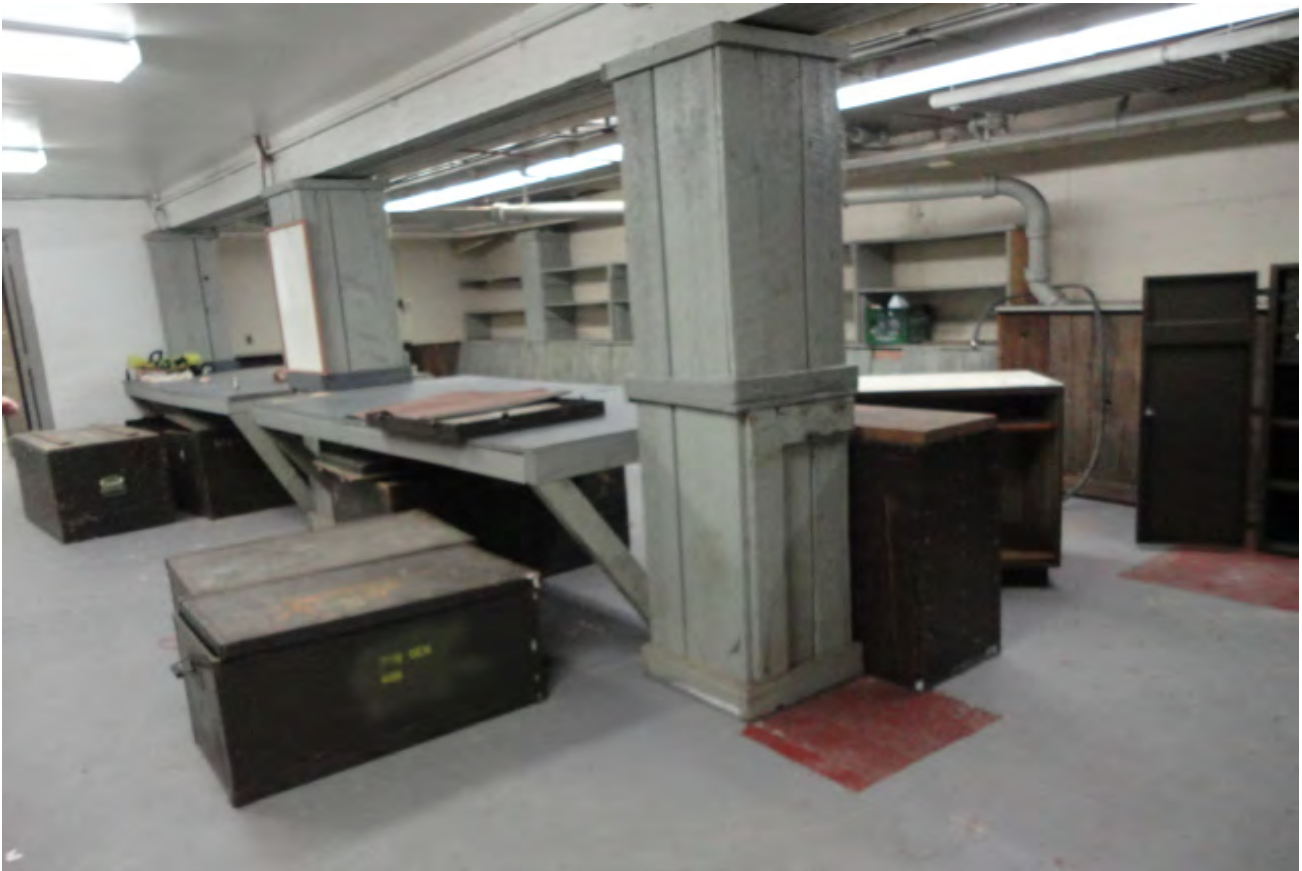
Photograph 12: View of a former unit storage area in the basement. This room was mostly empty except for a small crate of cleaning supplies (seen to the right of the foreground pillar) and a small microwave oven.

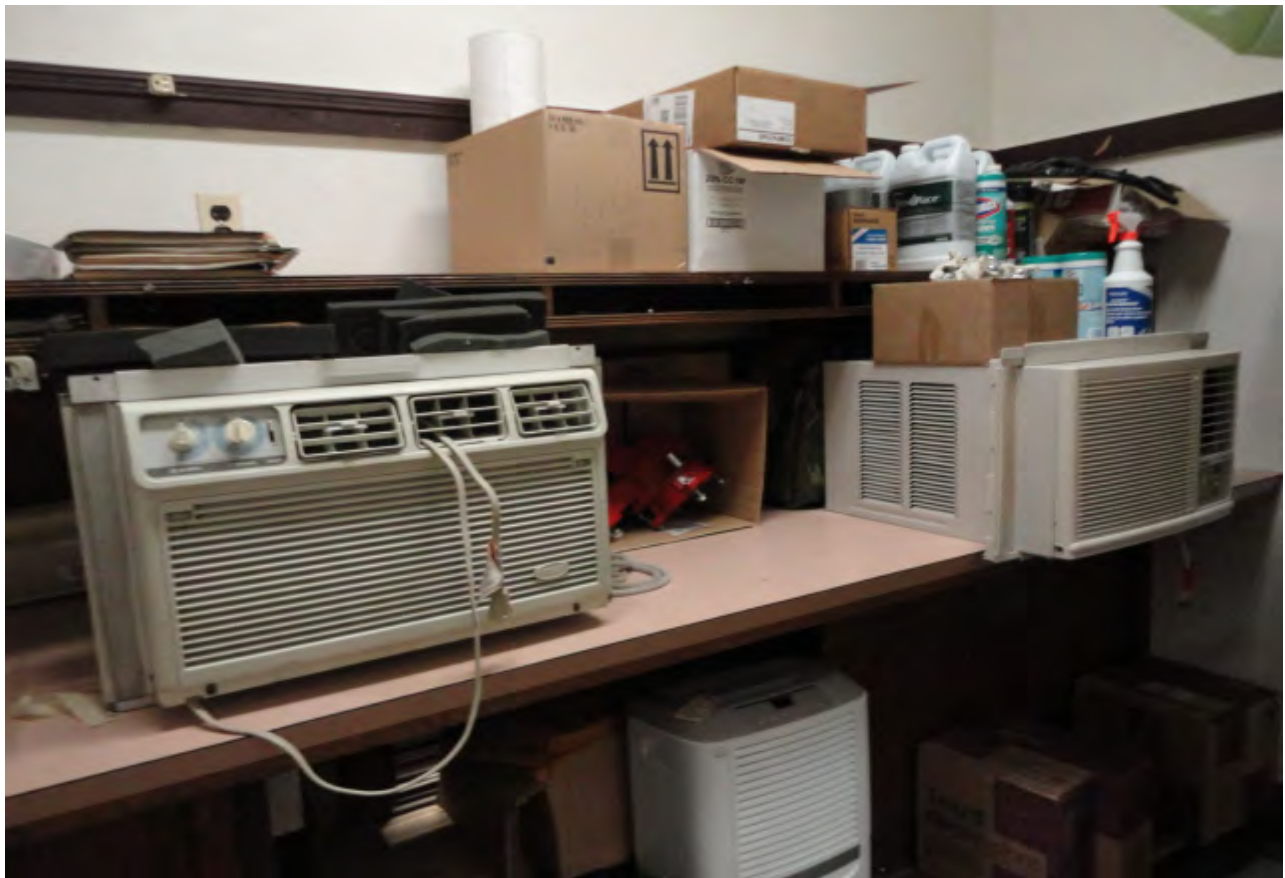
Photograph 13: View of window-mount air condition units in a first floor maintenance storage room.

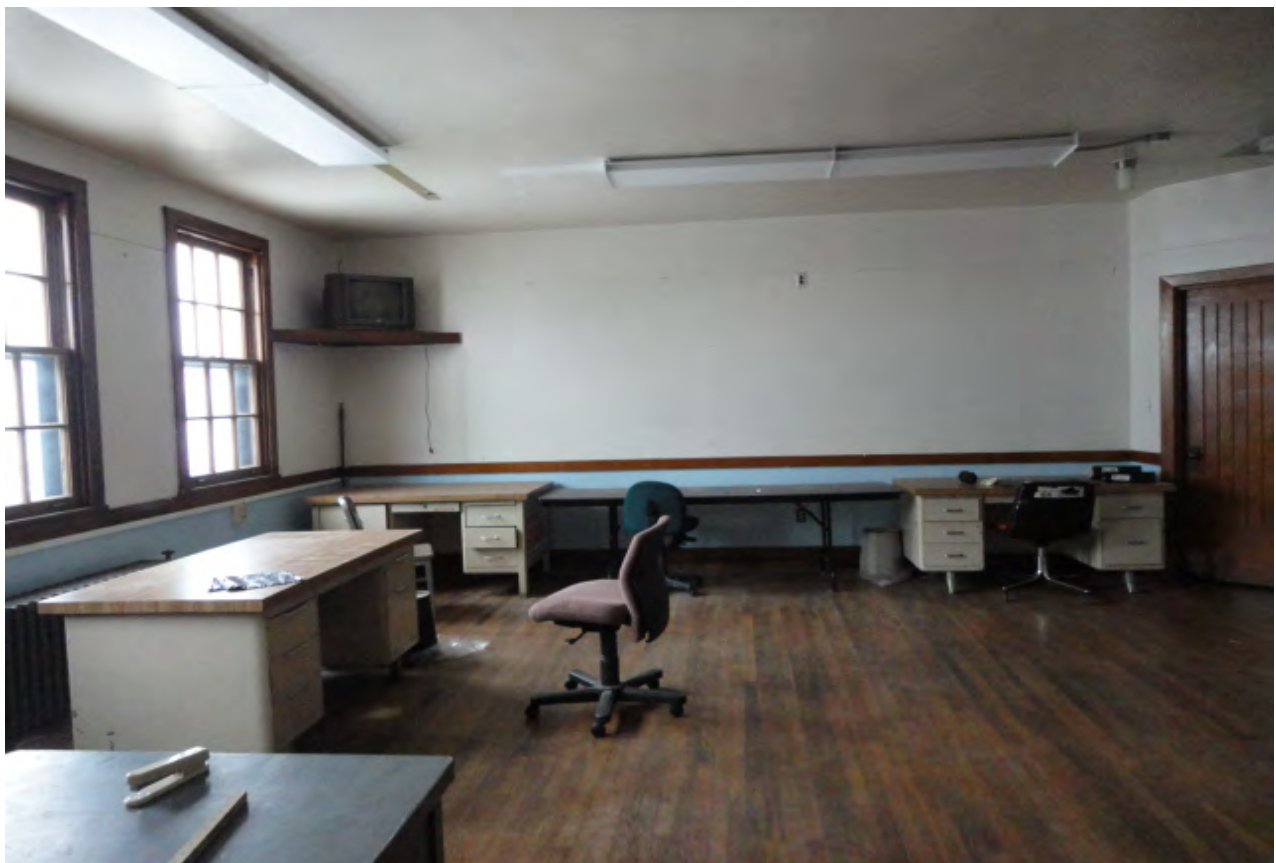
Photograph 14: View of the large 2<sup>nd</sup> floor office space. Note the television set remaining on the east wall.

Several electronic items, including two television sets (in the drill hall storage room and in the second floor common office area), a printer and fax machine are still present in the office areas of the first and second floors of the RC. Two small microwave ovens, as well as, three window-mount air conditioning units are still present inside the RC building. A desktop computer reportedly left behind by the unit formerly occupying the RC was observed in the basement dispatch room. These items are not necessarily considered hazardous wastes, however, as they could be reused, and most likely fall under the electronic, or "e-waste" category. The computer should be turned into the G6 at FTIG for processing and disposal. The EPA and PADEP generally do not consider electronics and household appliances to be wastes until a decision has been made that they cannot or will not be reused. A waste determination should be made for these items and treated accordingly.

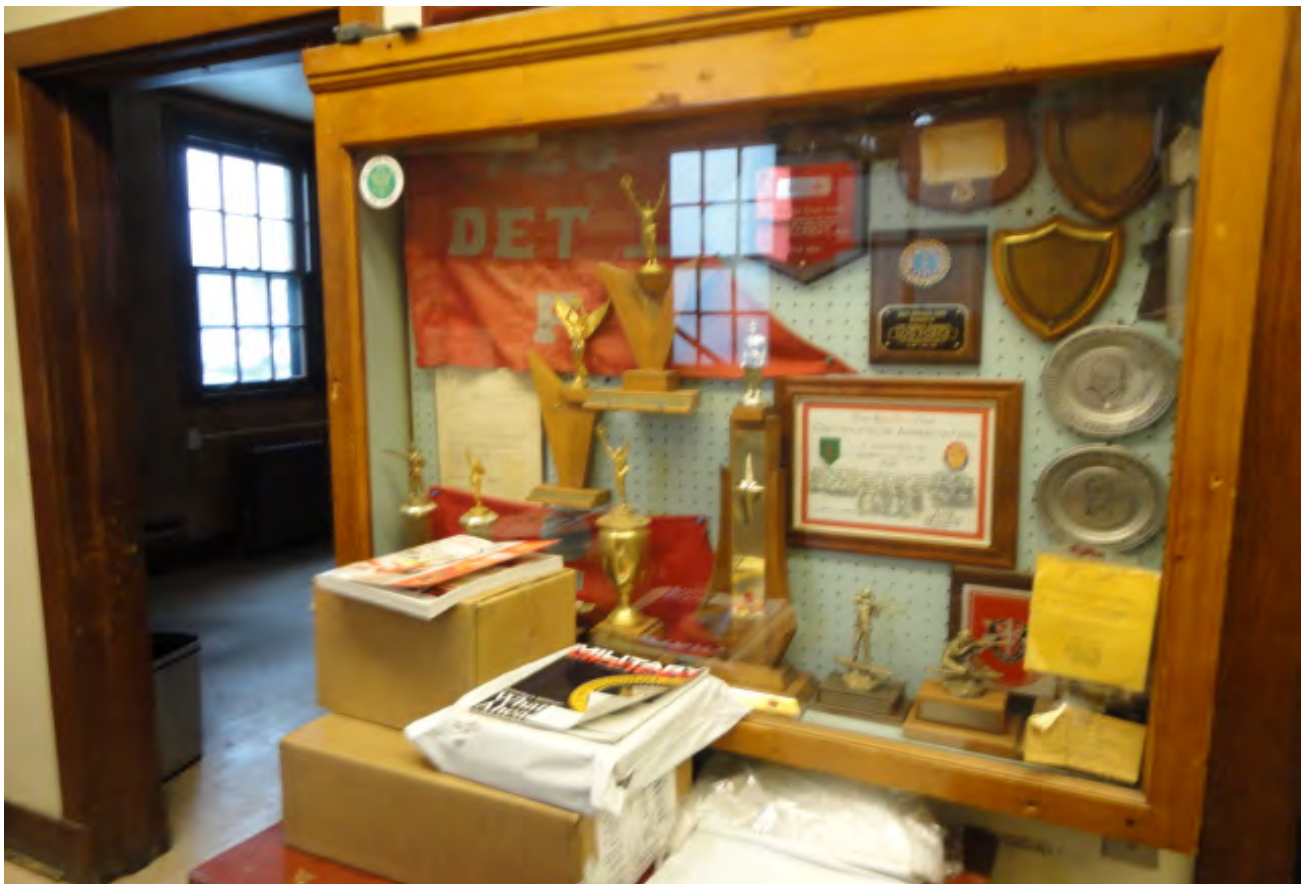
Photograph 16: View of remaining cultural items in the first floor entrance hall.

4. A previous evaluation of the Kane RC parcel for historical and architectural significance resulted in the listing of the Kane RC building on the NRHP as of 9 May 1991. Several potential cultural resources and related items are still present onsite, including several unit flags or guidons, multiple trophies and framed certificates, and several black-and-white photographs. Additional consultation with PADMVA's Cultural Resource Manager in regards to the items noted above may be necessary prior to the final disposal of the Site. Any verified cultural items for which the unit has no use may be turned over to the Pennsylvania National Guard Museum at Fort Indiantown Gap.

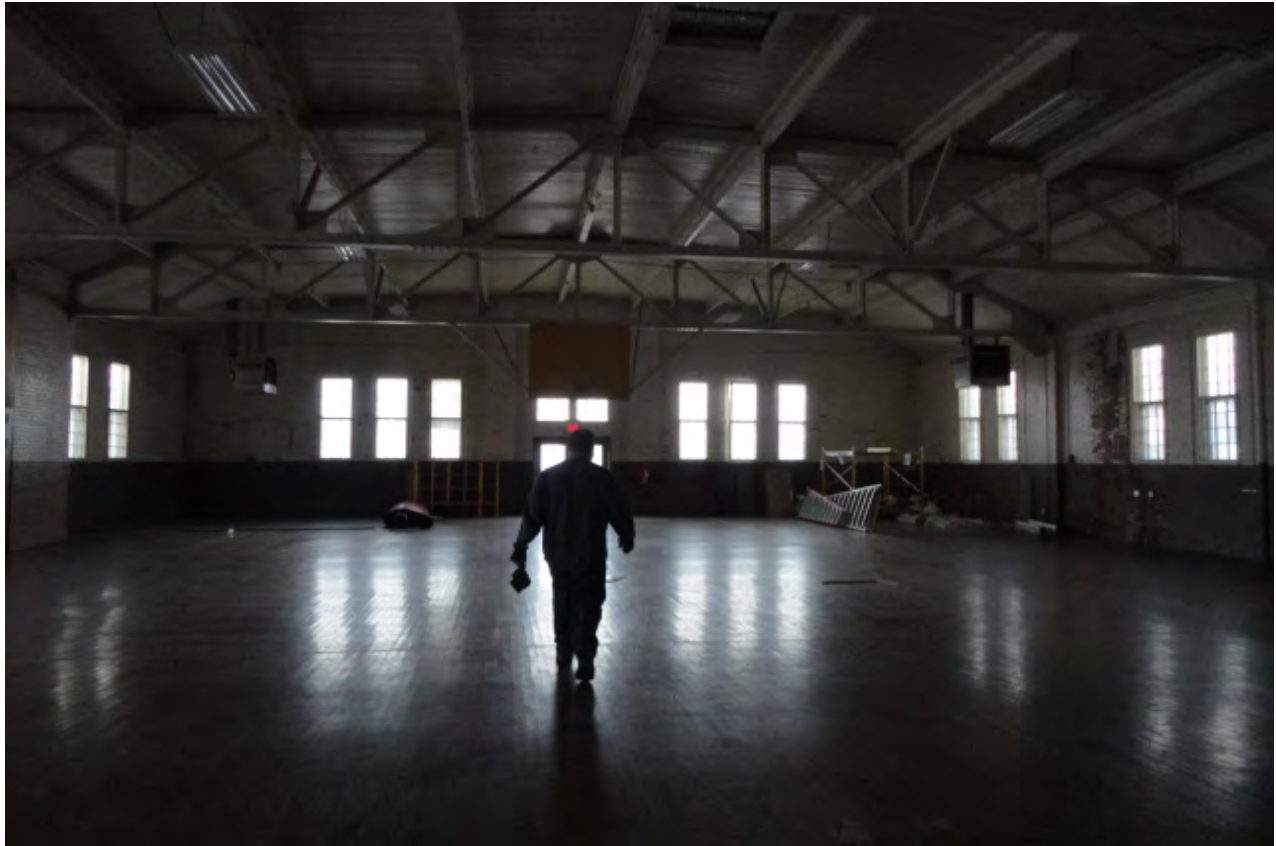
Photograph 17: View to the south of remaining items in the RC drill hall, much of which were maintenance-related items, such as ladders and light fixtures.

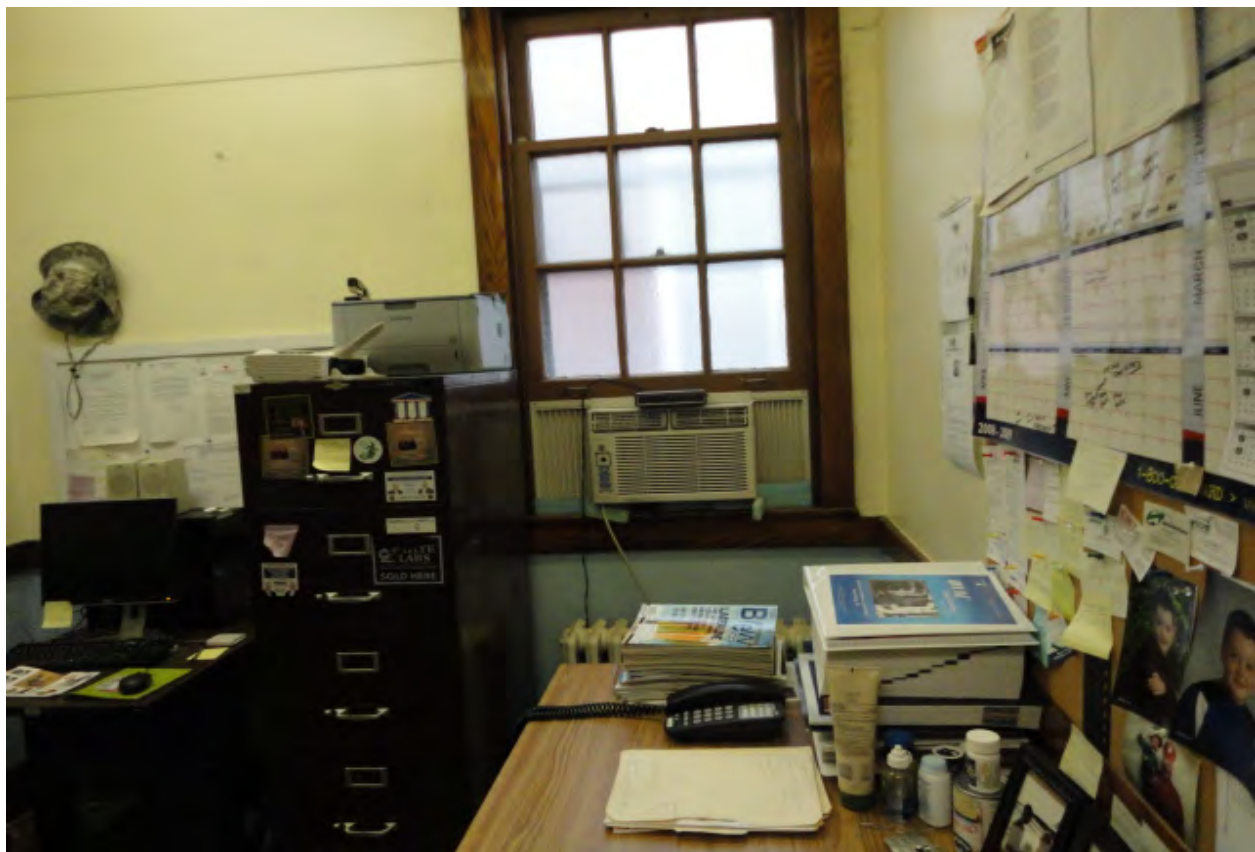
Photograph 18: View of remaining window-mounted air conditioning unit in the second floor maintenance office.

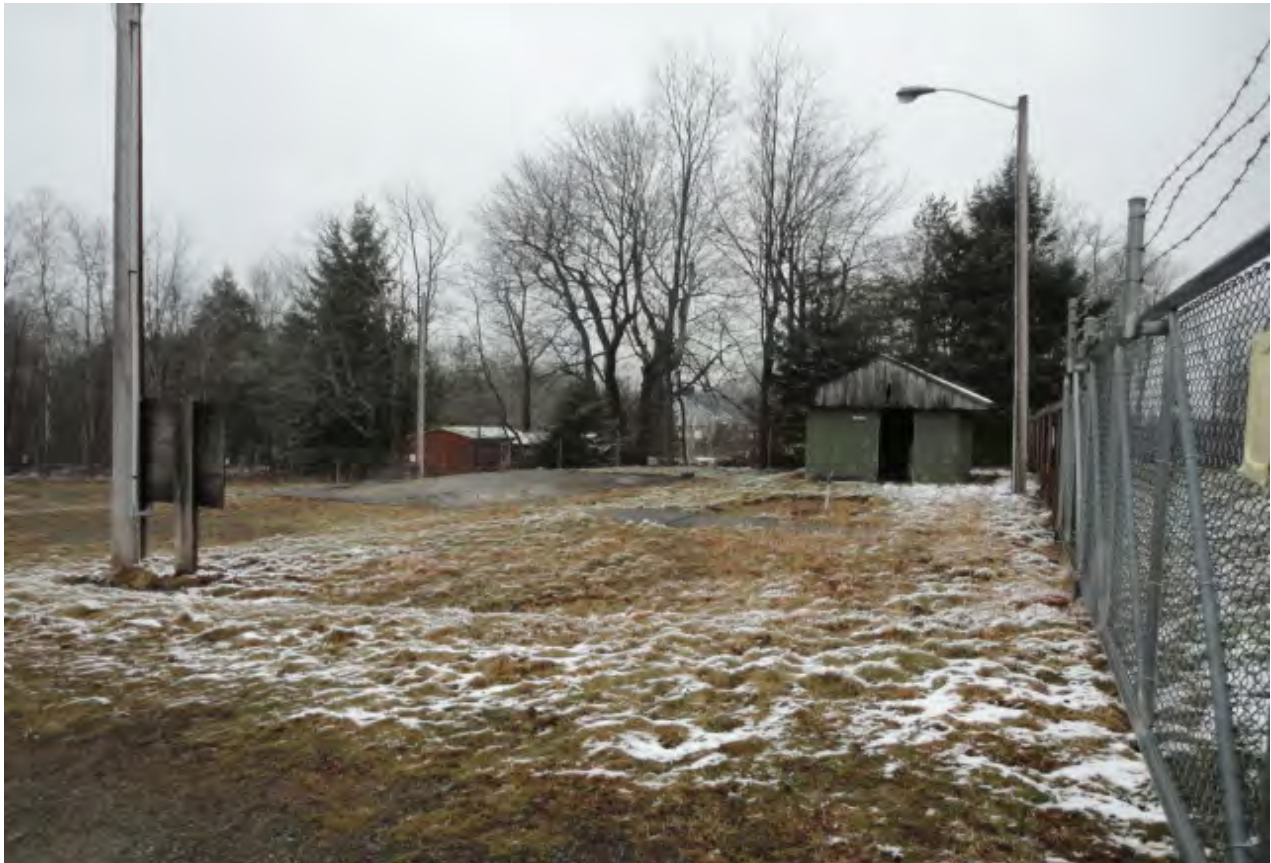
Photograph 20: View to the west of the small unit storage building and adjacent concrete pad. An area of bare earth can be seen in front of the storage building where a portable unit storage container formerly sat.

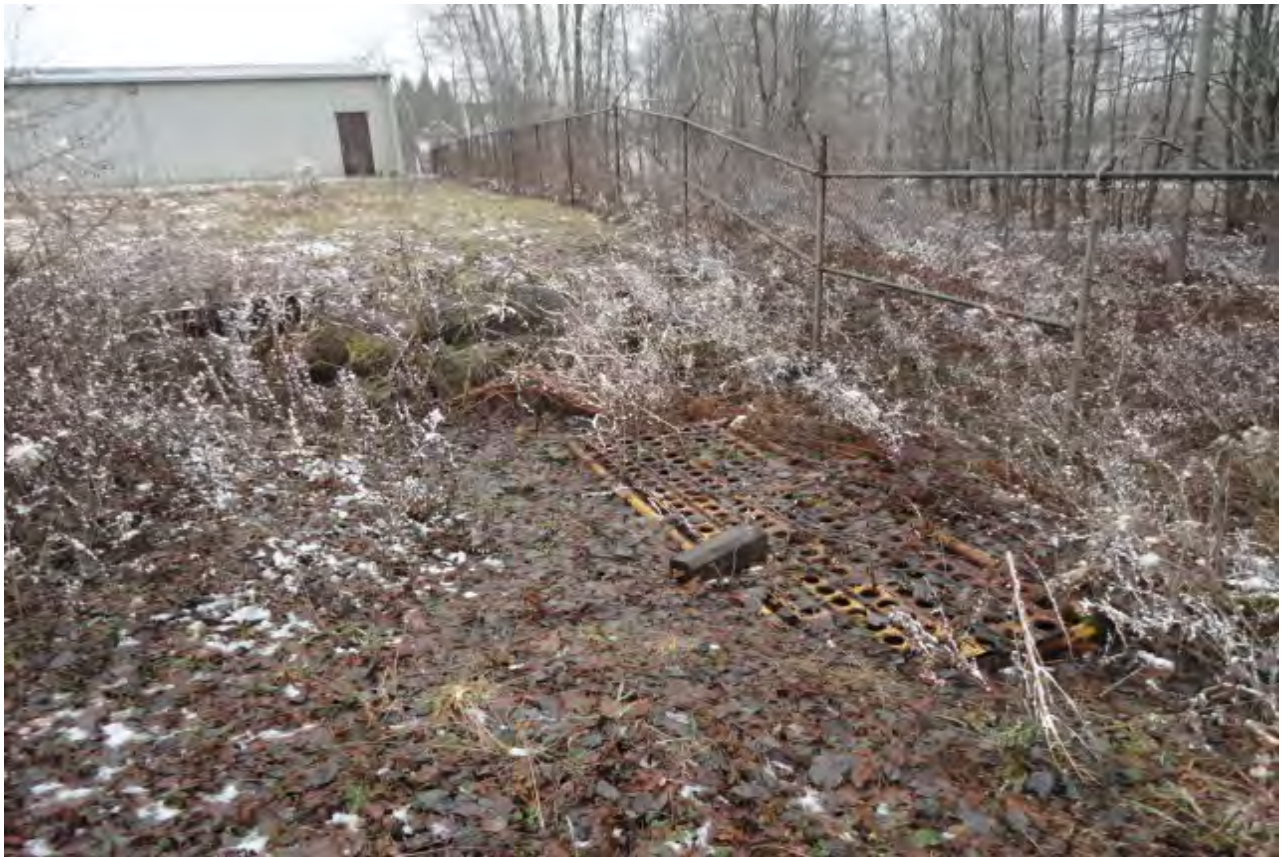
Photograph 30: View to the east of a stormwater drainage area along the southern fenceline. The former grease rack was reportedly located between this feature and the large unit storage building in the background.

A review of agency files did not indicate the presence of significant historic spills or other releases of hazardous waste or other hazardous materials on the Kane RC and WETS parcels. A grease rack was formerly present near the southern fenceline at the WETS parcel; this feature was removed from the WETS parcel sometime prior to July 2007. PADMVA environmental personnel evaluated the former rack location on 13 July 2007, noting that there were “no visible signs of contamination (no staining or dead vegetation) around the former rack location.” The collection of soil samples in this area was suggested for confirmatory purposes, but it is not likely that said soil sample collection was completed, as no laboratory analytical results or other related documentation was found with PADMVA’s files. During the Site reconnaissance, remaining chemical, petroleum, or other hazardous material storage containers were not observed at the WETS parcel facilities. There were no obvious signs (e.g., staining, dead vegetation, waste piles) of significant material spills at the WETS facility during this assessment.
