SUBJECT: Industrial Hygiene (IH) Survey

INDUSTRIAL HYGIENE SURVEY  
COMPLETED FOR THE  
Pennsylvania Army National Guard (ARNG)

East Stroudsburg Readiness Center  
Pennsylvania Army National Guard  
271 Washington Street  
East Stroudsburg, PA

SEPTEMBER 11, 2017

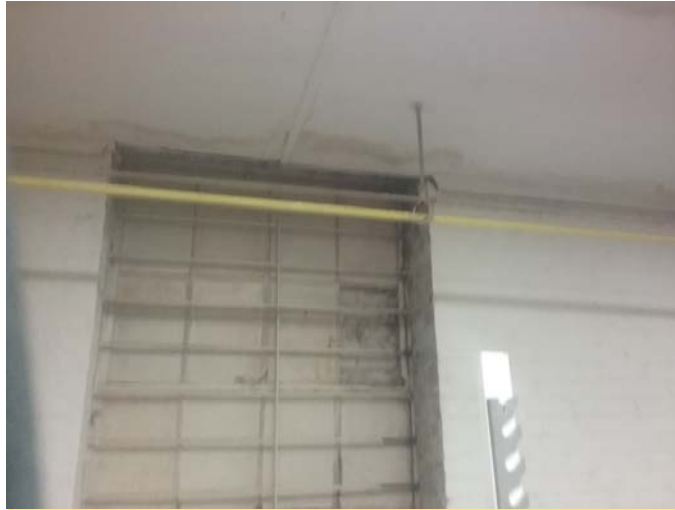
Water damage was found on the ceiling, walls, and associated building materials in the gym. It was reported that the water damaged was caused by water intrusion from a leak in the adjacent window. There was also suspect water damage on the walls by the front entrance, with peeling paint, caused by the major flood that occurred here.

1. Water damage on ceiling in the Gym

2. Ceiling, walls, and associated suspect water damaged building materials should be removed and replaced in the gym and hallway by the entrance. A mold inspection should be conducted to ensure mold growth is not present in water damaged areas. (Reference 6). RAC-5

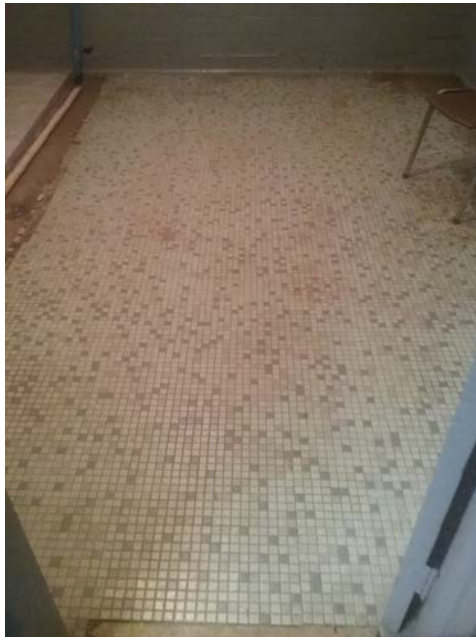
There was presumed asbestos-containing materials in the shower room. We were told during a walkthrough that the floor tiles in the Shower Room contained asbestos, and the edge of the tiles by the drain contained friable asbestos. The tiles were replaced in a portion of the room by the shower. A picture of the tiles is attached.

2. Damaged potential asbestos containing floor tiles

6. Remediate damaged Presumed Asbestos Containing floor tiles in the Shower Room. Develop and implement an operations and maintenance program (Reference 1). RAC-2

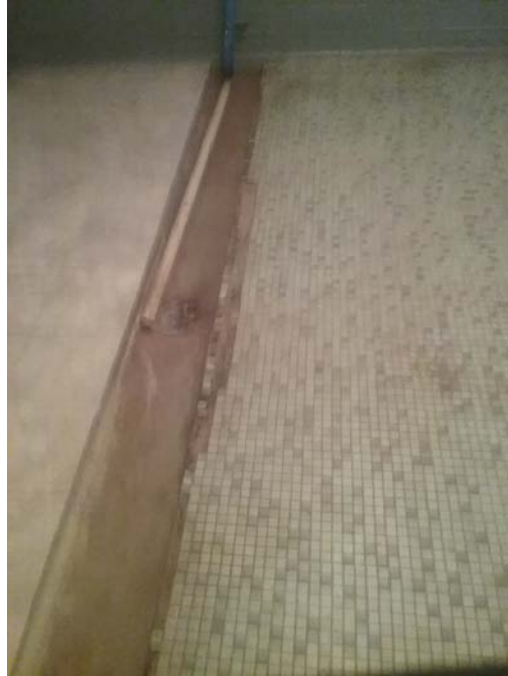
3. Damaged potential asbestos containing floor tiles

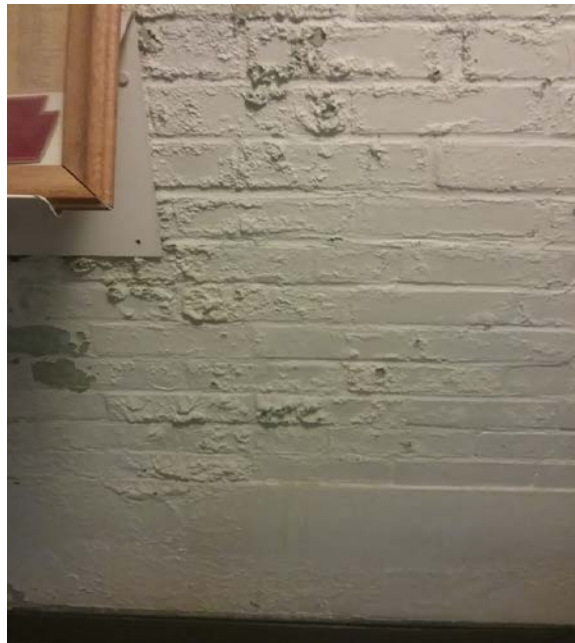
4. Suspect water damage on wall in hallway near main entrance
